REPORT ON THE FAILURE
OF THE
EMPRESS DOCK NORTH WALL
BY
J. Wolfe Barry.
1888,

SOUTHAMPTON DOCKS.

DEEP WATER DOCK.

SECTION OF NORTH WALL.
Scale 1 in = 12 ft.

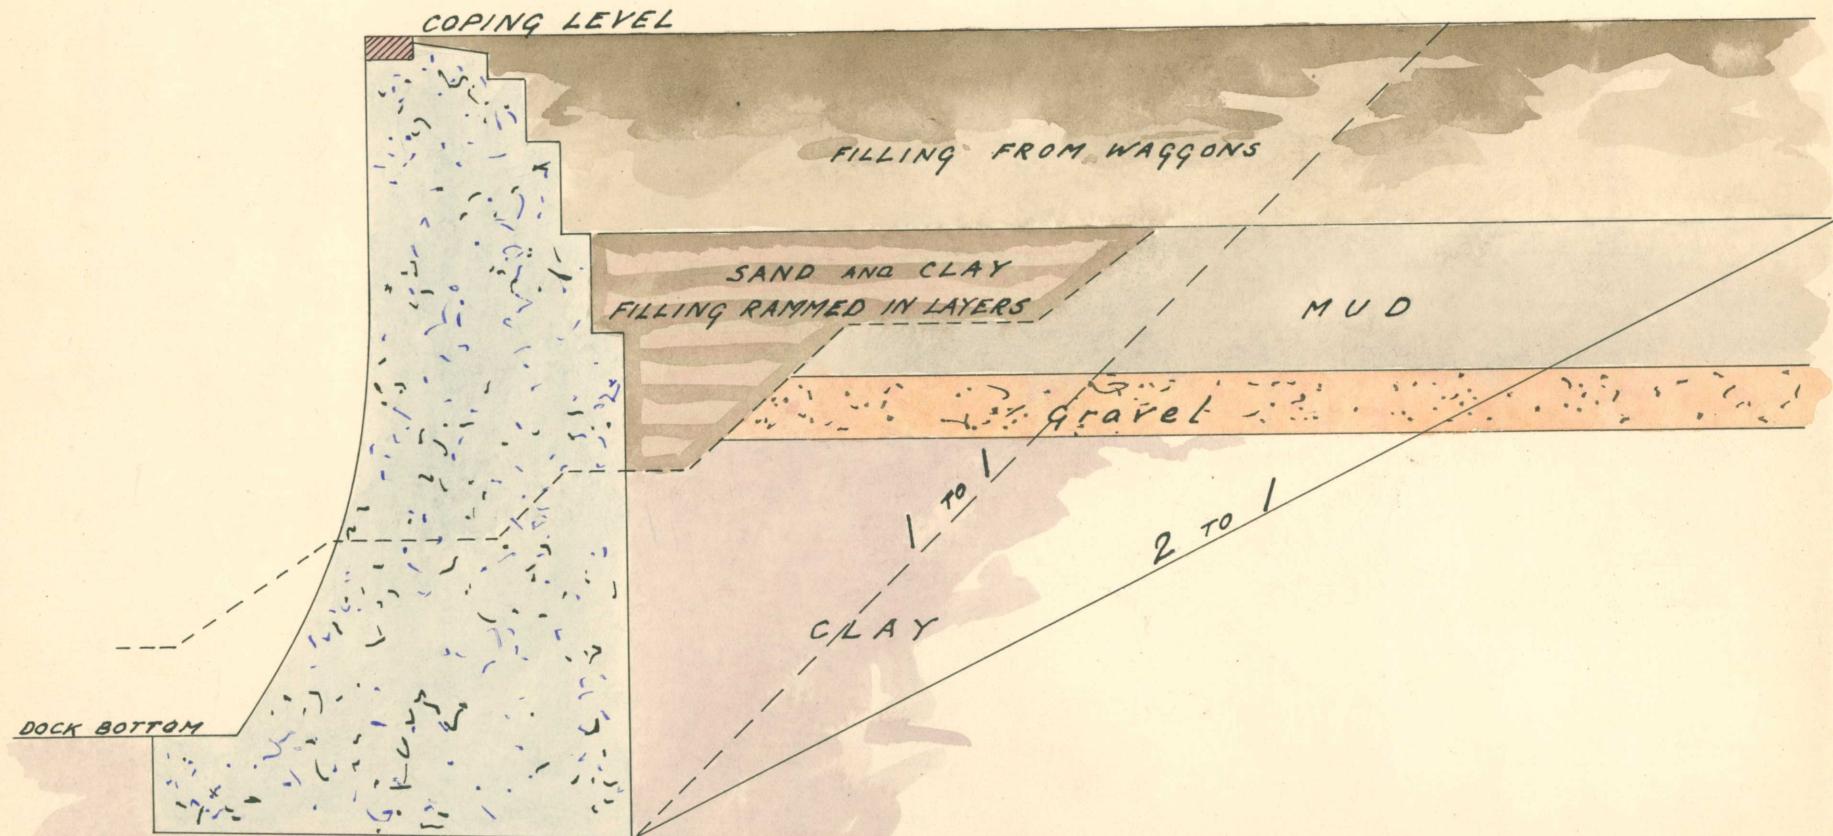
The wall which is made of concrete consisting of good gravel and portland cement in the proportions of 8 to 1, is 51 feet high from its base to the coping , has a thickness of 30 feet
3.

in width at its base, and of 24 feet at Dock Bottom. The thickness at the top is 10 feet, and there are 4 steps or offsets at the back of the wall, each 2 feet wide. The face of the wall is curved and the back is vertical. The base of the wall rested on a slight incline upwards from back to front of 6 inches, equal to a slope of 1 in 60.

The nature of the soil behind the wall was as follows, reckoning from the base of the wall upwards. About 23 feet of clay was left vertically behind the wall which was erected in a timbered trench, and I am informed that great care was exercised

to ensure that the concrete was tight against the front and back faces of the clay. Above this level there was a further depth of about 3 feet of clay, then 4 feet of gravel, then 8 feet of soft mud. All these layers of soil were in their natural order of stratification. Above the level of 23 feet from the base of the wall, the clay gravel and mud had been more or less removed and replaced by earth filling as will now be described.

The earth filling was executed as follows. — At immediately behind the wall from a point 23 feet above the base, the clay gravel and mud were sloped backwards at an angle of about

1 vertical to 1 horizontal to a point half way
of the thickness of the mud, at which level the
mud was removed for a distance horizontally
from the back of the wall of about 22 feet.
Beyond that distance the mud was left with
a slope of about 2 to 1. The space due to
the removal of the clay and mud was filled
with earth filling from the site of the dock, and
this filling was, I believe, rammed in horizontal
layers up to the level of the top of the mud. Above
that level the same description of filling was
deposited from ordinary earth waggons or
barrows and was not rammed in layers.

up to coping level or thereabouts and the wall gave way about a week afterwards. The above description of the wall and backing which is I believe at least approximately correct, will be better understood from the accompanying cross section.

that allowing for the sloping back of the clay and the removal of the mud, the slope of the ground behind the wall from the base of the wall to the top of the rammed filling was approximately 1 to 1 and that above the mud there was a height of about 13 feet of backing resting on a bed of mud.

I consider that ground such as I have described would not stand at such a slope as 1 to 1 but would more probably require a slope of 2 to 1 for stability. The ground behind the wall would thus give rise to very considerable horizontal pressure which would be much in excess of that produced by ground and backing such as is ordinarily

To sum up therefore, my reply to your first question is, that the cause of the misfortune was, in my opinion, the existance close behind the wall of the mud and clay, and of the presence of water in the gravelly bed, coupled with the fact that the backing, rammed in layers, had so much clay mixed with it, that water could not readily find access to the pipes which had been provided through the wall for the purpose of relief.

in rebuilding the wall are, in my opinion to carry its foundations considerably deeper into ground undisturbed by the movement which has taken place and to remove the clay and mud to a much greater distance behind the wall, replacing them with more and better backing, which should rest on horizontal beds. In addition to this, all soaks and drains of water from the gravel should be led through the backing to the drain pipes through the wall so as to avoid as far as possible any action of the water on the Clay beds.

I think that the steps which should be
taken at the present time in respect of the
other walls are in the direction of diminishing
the pressure behind the walls by using a greater
width of backing, resting on horizontal beds,
and in improving its quality, keeping at all
times a free exit through the wall for any water
which may accumulate in the gravel beds.
