Securing Mulberry: Mulberry Harbour Kite Anchor Remains

**A historical and physical assessment of the archaeological remains
of Mulberry Harbour moorings on Peel Bank, off Woodside, Isle of
Wight**

May 2018

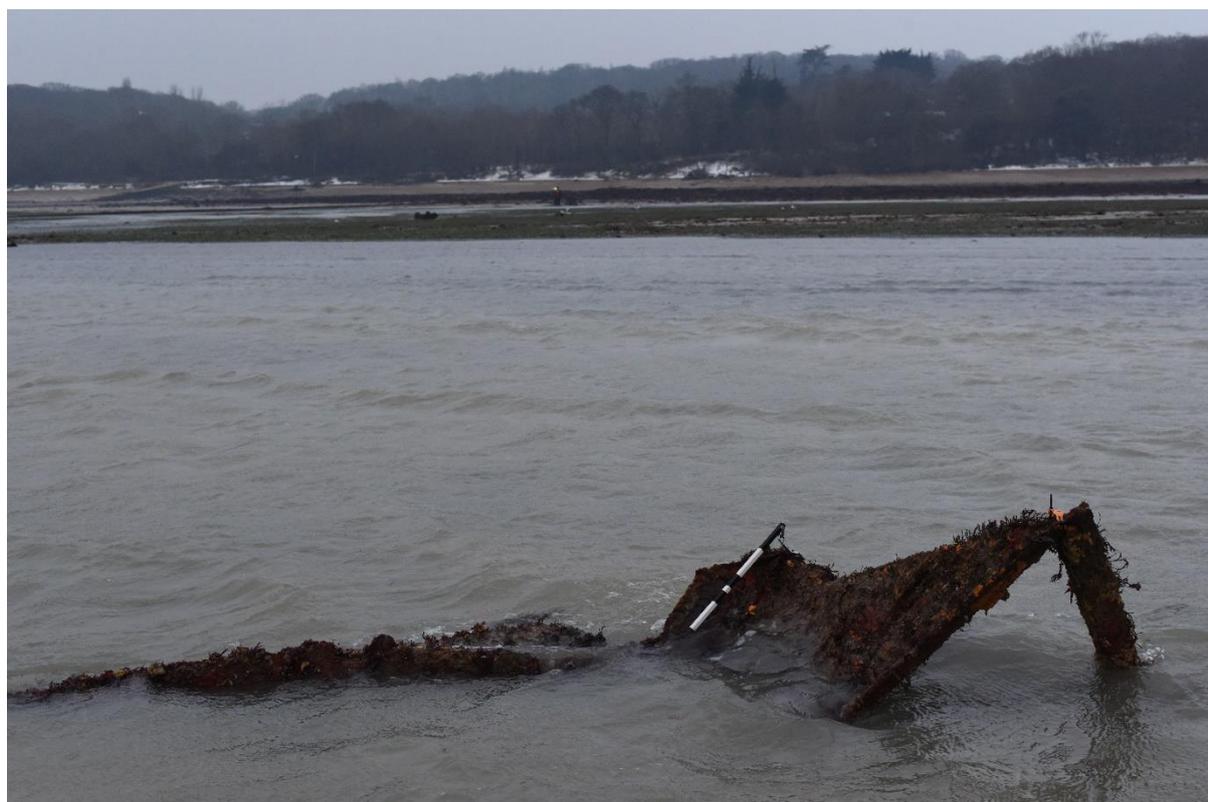
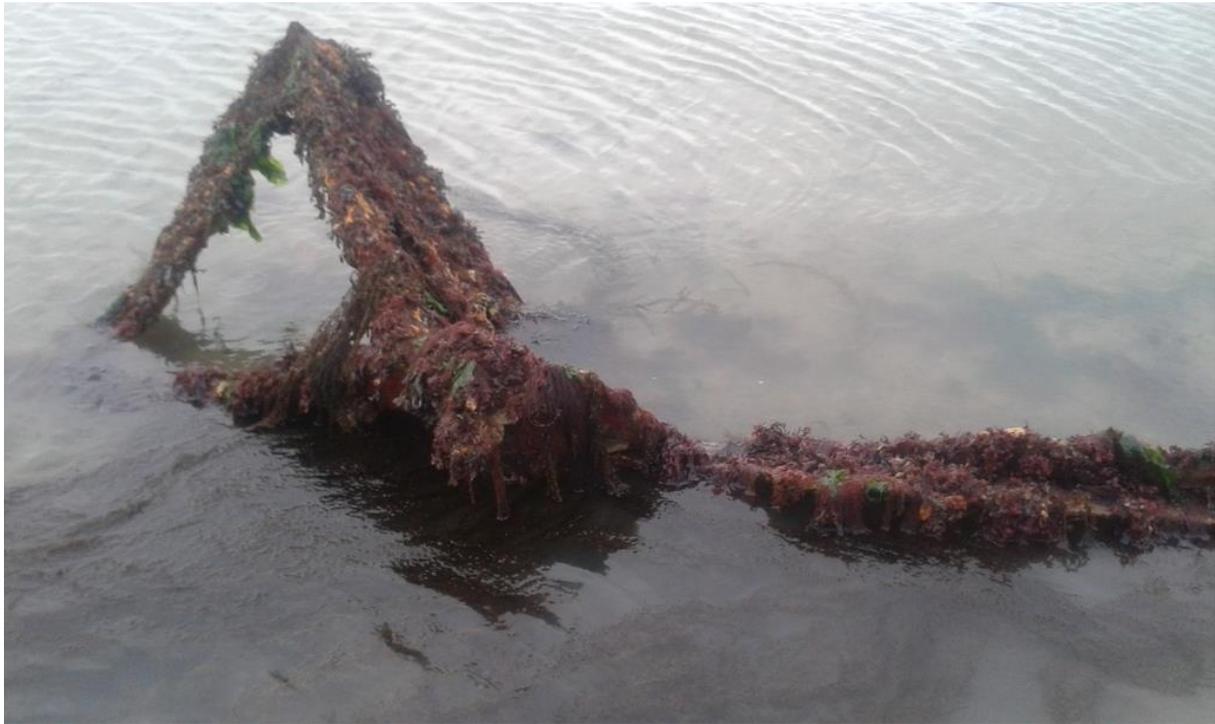
This anchor is only partially visible at low water and appears to be on its side. There is some concretion and much marine growth on the external structure. It is difficult to assess the full condition of this anchor due to it being partly submerged. The arm of the anchor is complete and the main structure is in place though much of the plate has corroded.

Figure 10. Kite Anchor K1 at low water looking back to the shore line.

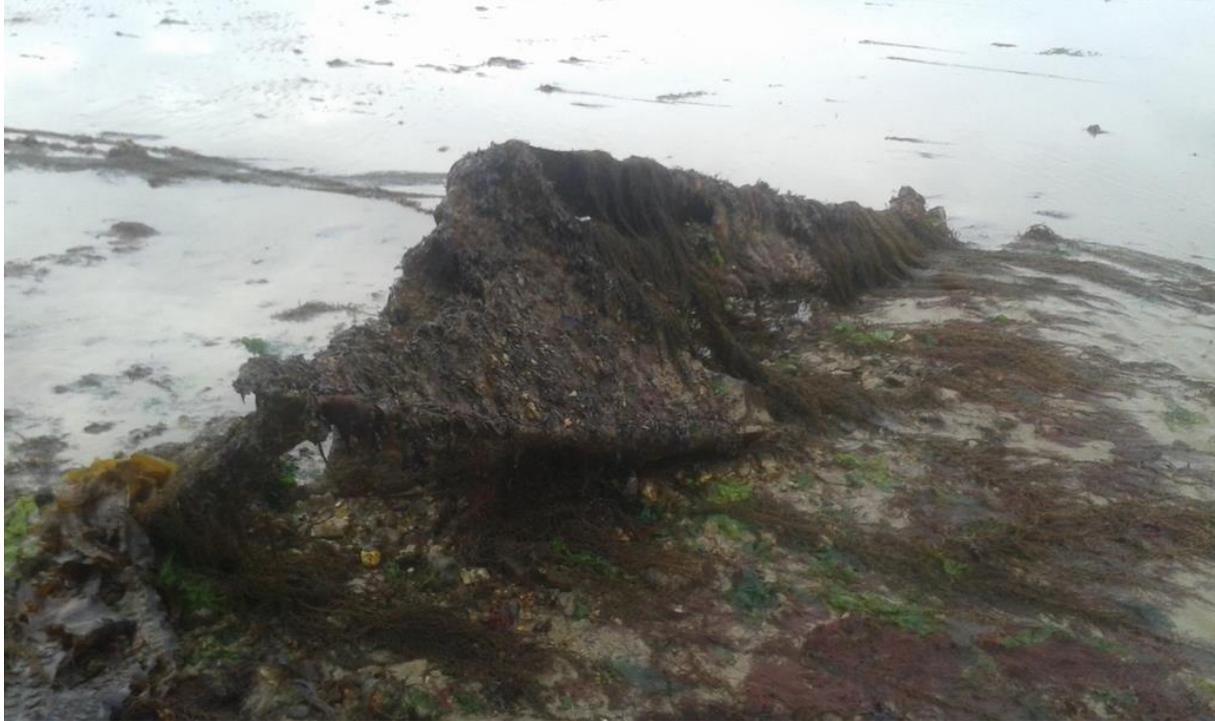
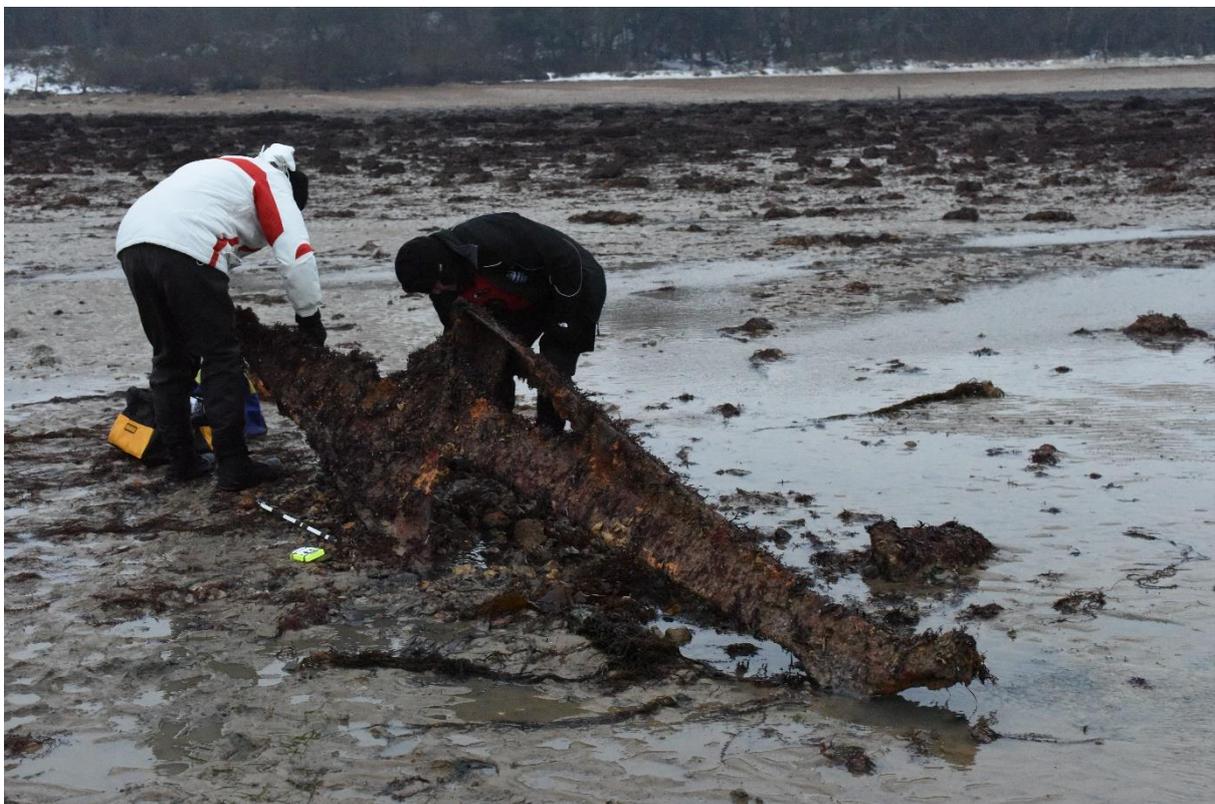
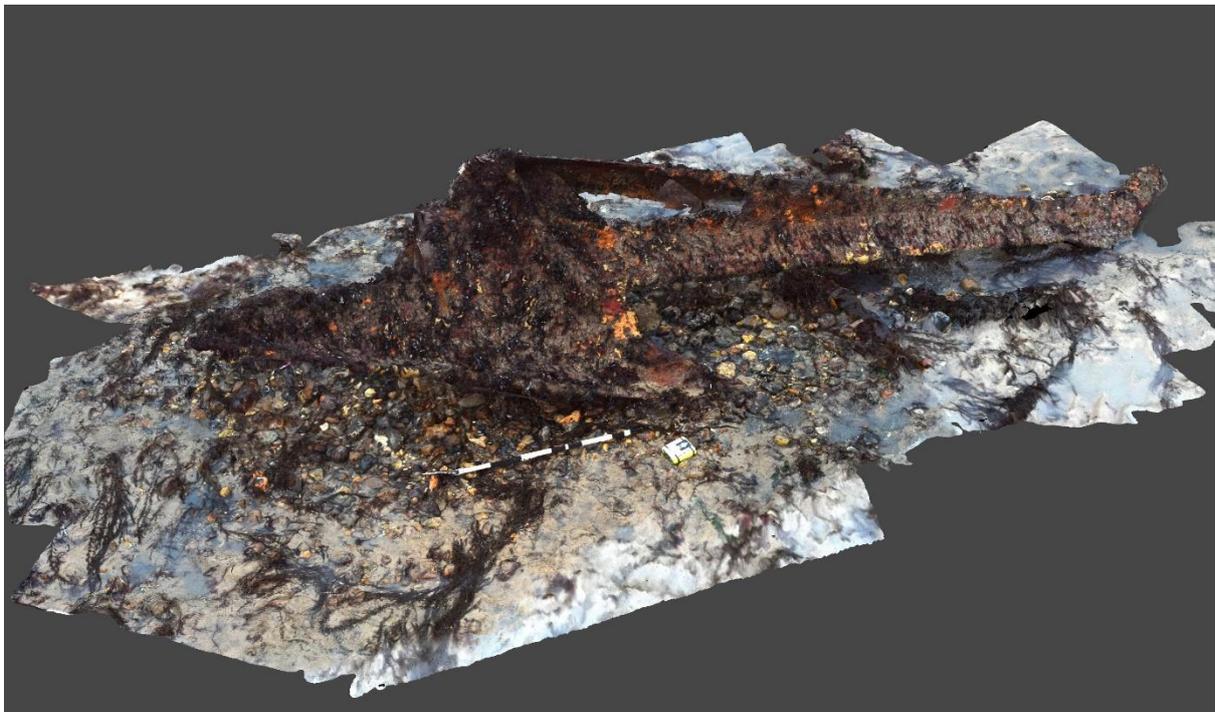
This Kite Anchor dries at low water and a photogrammetry model was made of the anchor in situ. The anchor is in reasonable condition though there is a large hole in the arm/shank where corrosion has set in. Much of the plating around the hook/blade has corroded away and the main structure is also beginning to collapse. Some marine concretion is present and there was a large amount of marine growth covering all parts of the anchor. Loose seaweed was removed for photographic purposes and to examine the condition of the anchor.

Figure 12. Kite Anchor K2 at low water was covered in seaweed.

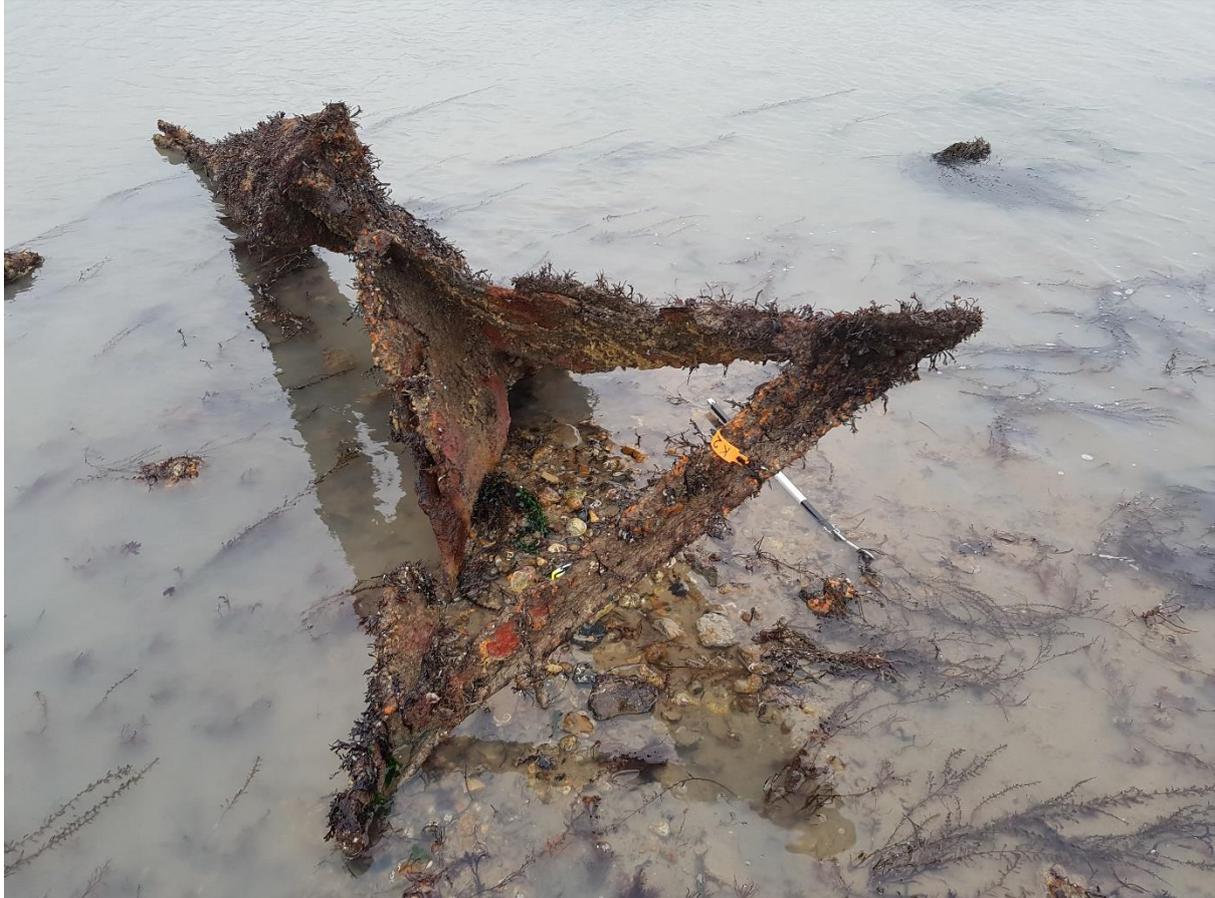
Figure 14. Kite Anchor K2 in shallow water showing the corrosion to the hook plates.

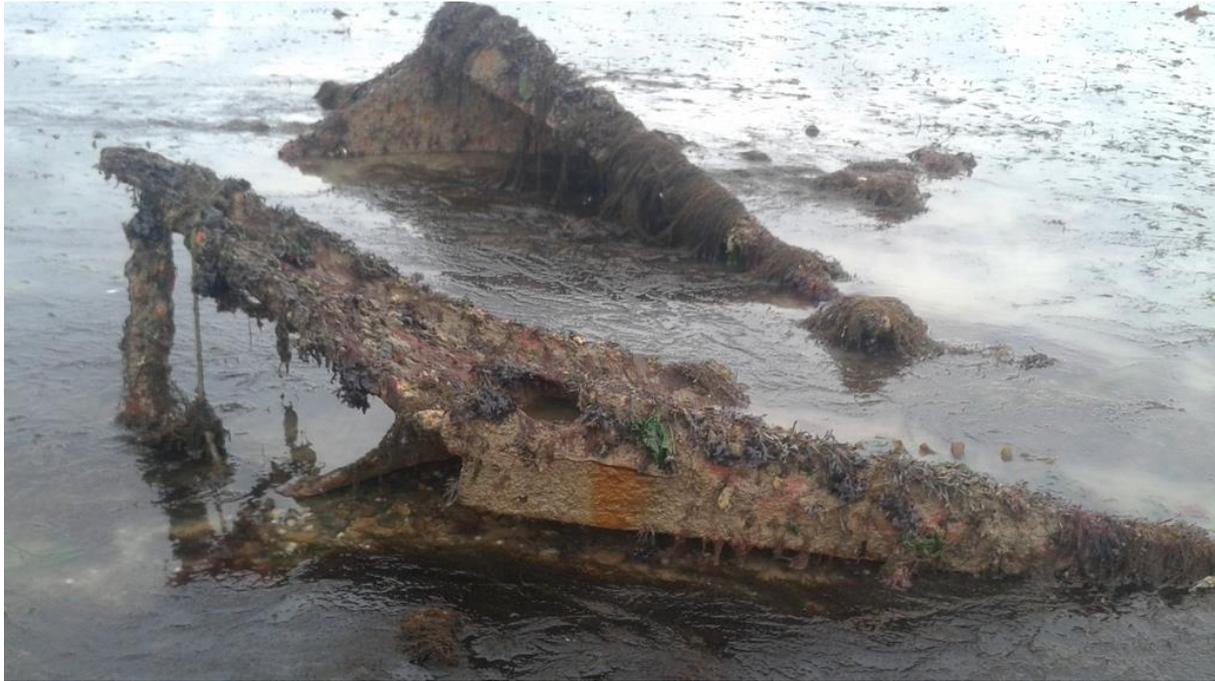
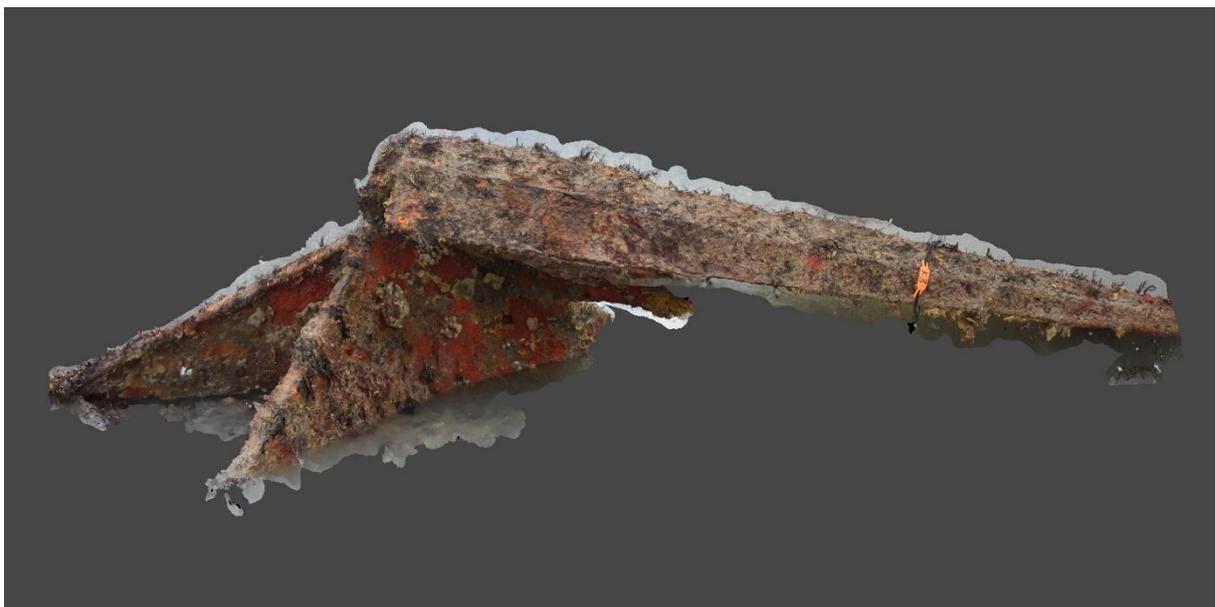
Anchor K3 does not dry completely and is only visible on the lowest of tides. A partial photogrammetry model was made of the anchor. The condition of this anchor is relatively good with much of the structure and hook plating still complete. However some parts of the anchor were not visible as they were underwater. The anchor arm and kite hook were concreted and covered in marine growth.

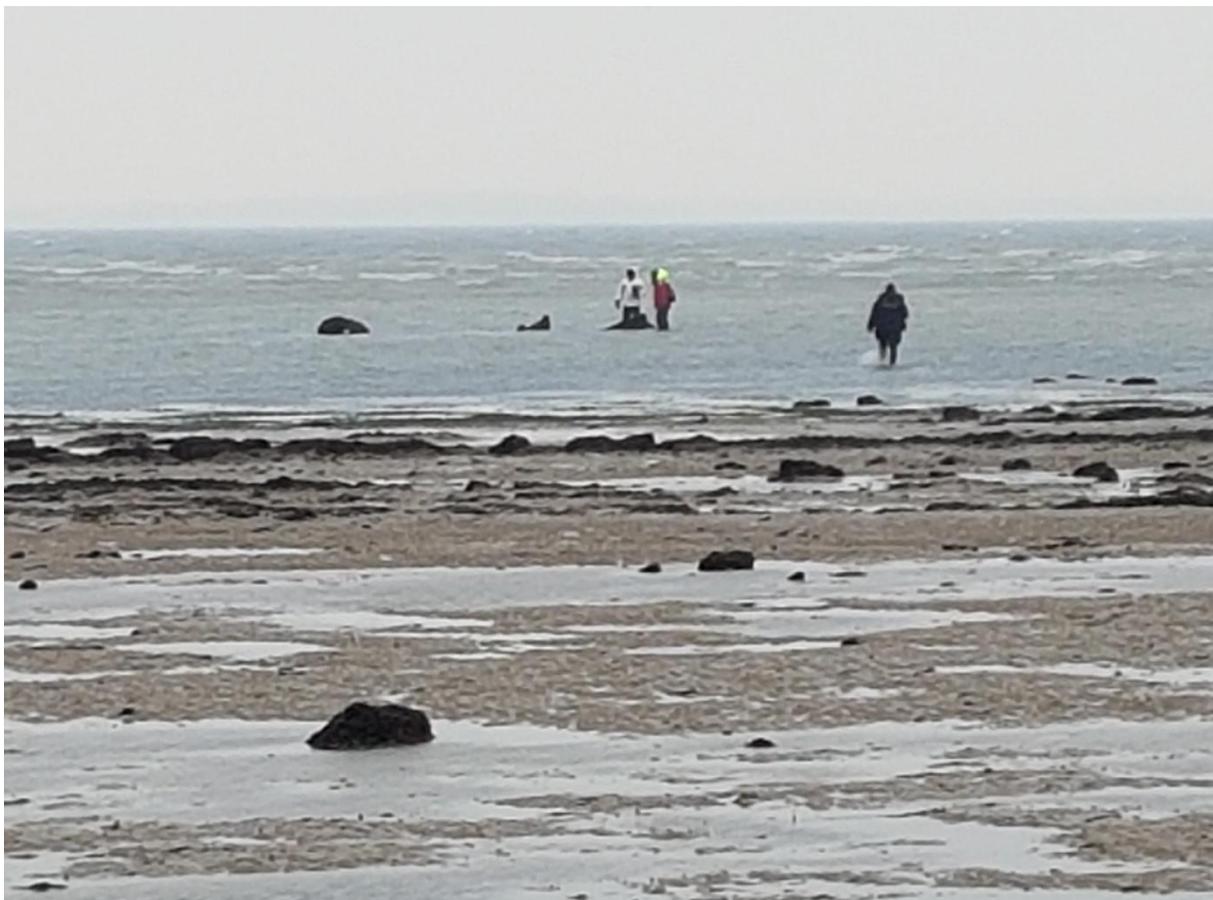
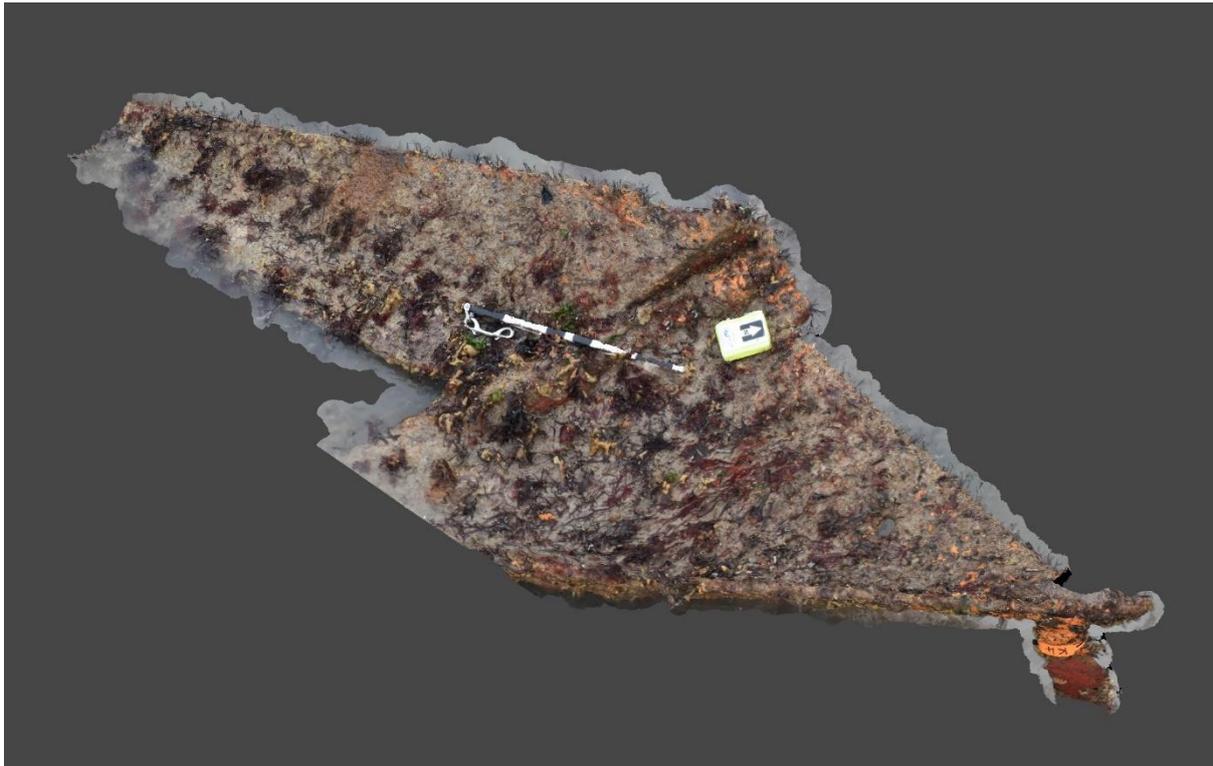
Anchor K4 is only a metre away from K3 and further submerged underwater. The component parts were visible and a partial photogrammetry model was made of the structure. The anchor is on its side and appears to be in reasonably complete and a similar condition to K3. It was concreted and covered in marine growth.

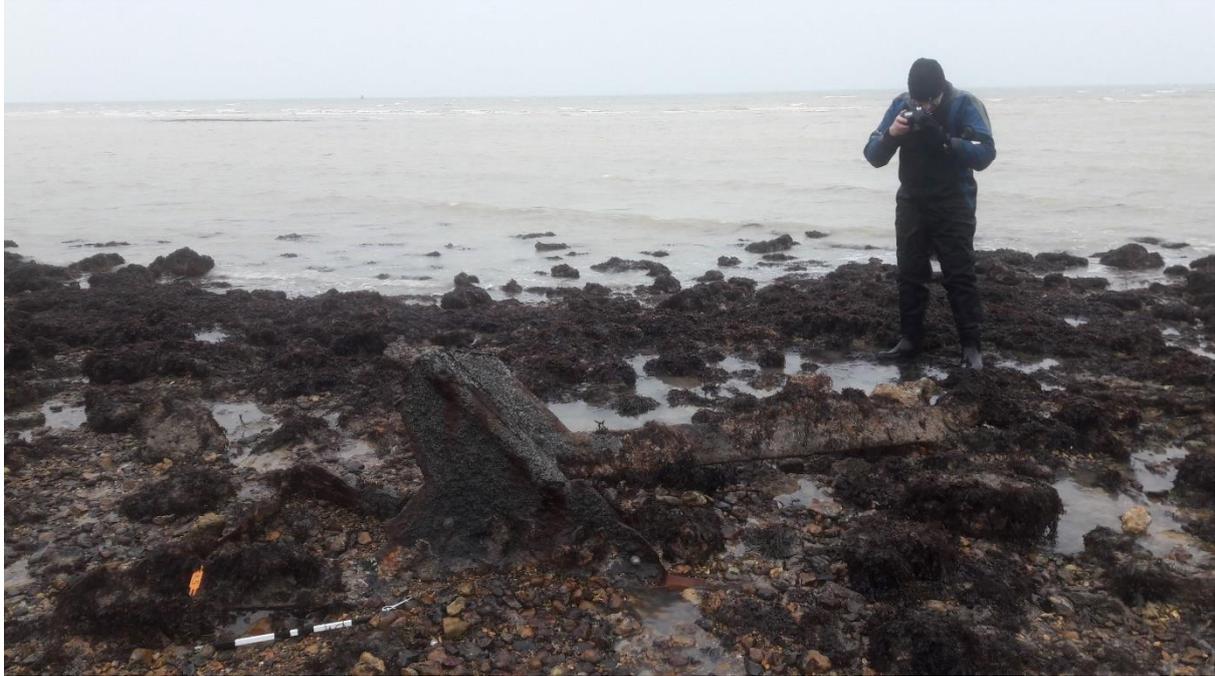
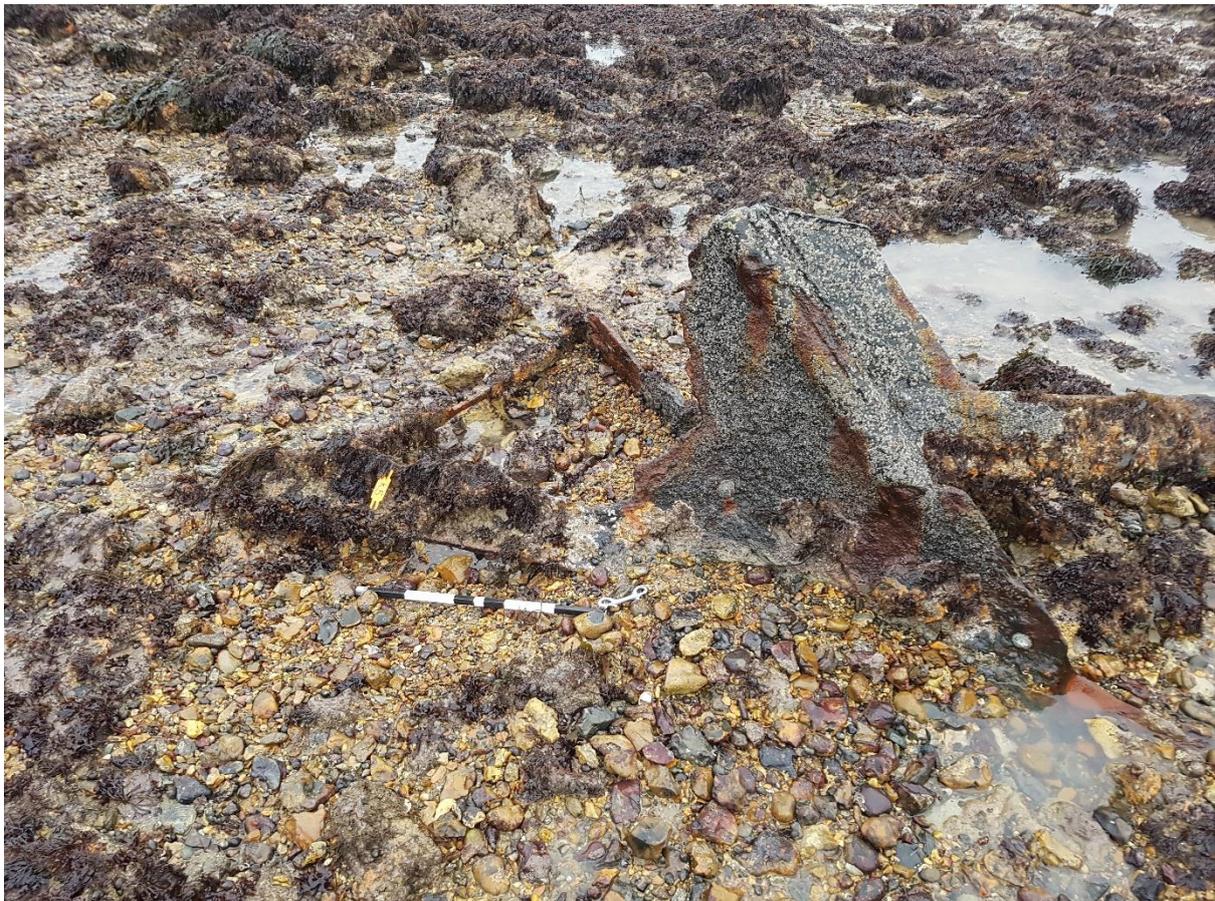
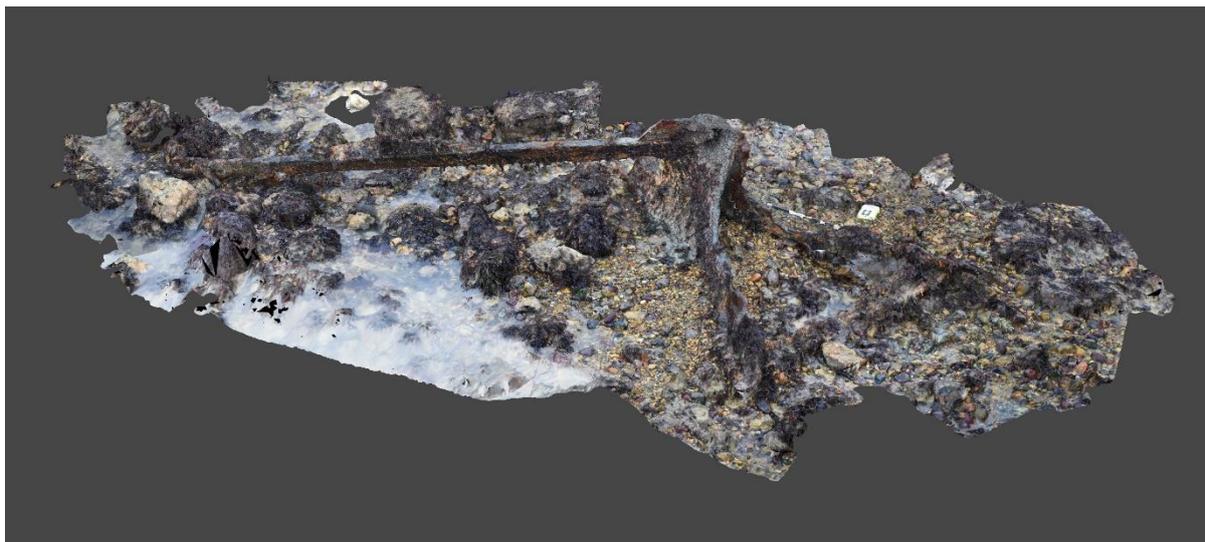
Anchor K5 is assessed to be in poor condition and has lost a lot of material from the shank and the plough / kite shape. It is not heavily concreted and there is exposed steel. The lack of concretion may have speeded up the corrosion process over time. Whilst still recognisable as a Kite Anchor it is considered the worst of the collection that was observed.

Figure 21. K5 anchor is in extremely poor condition.

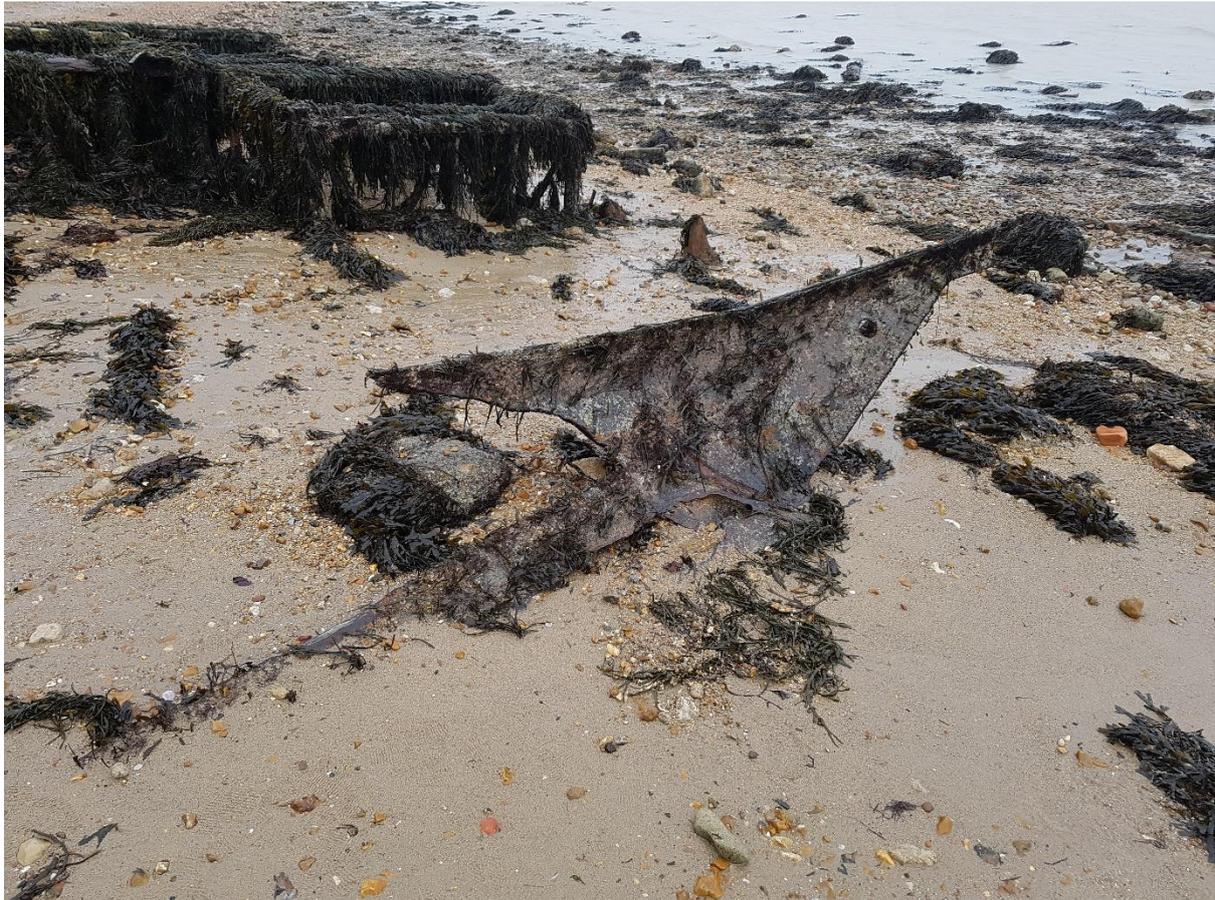
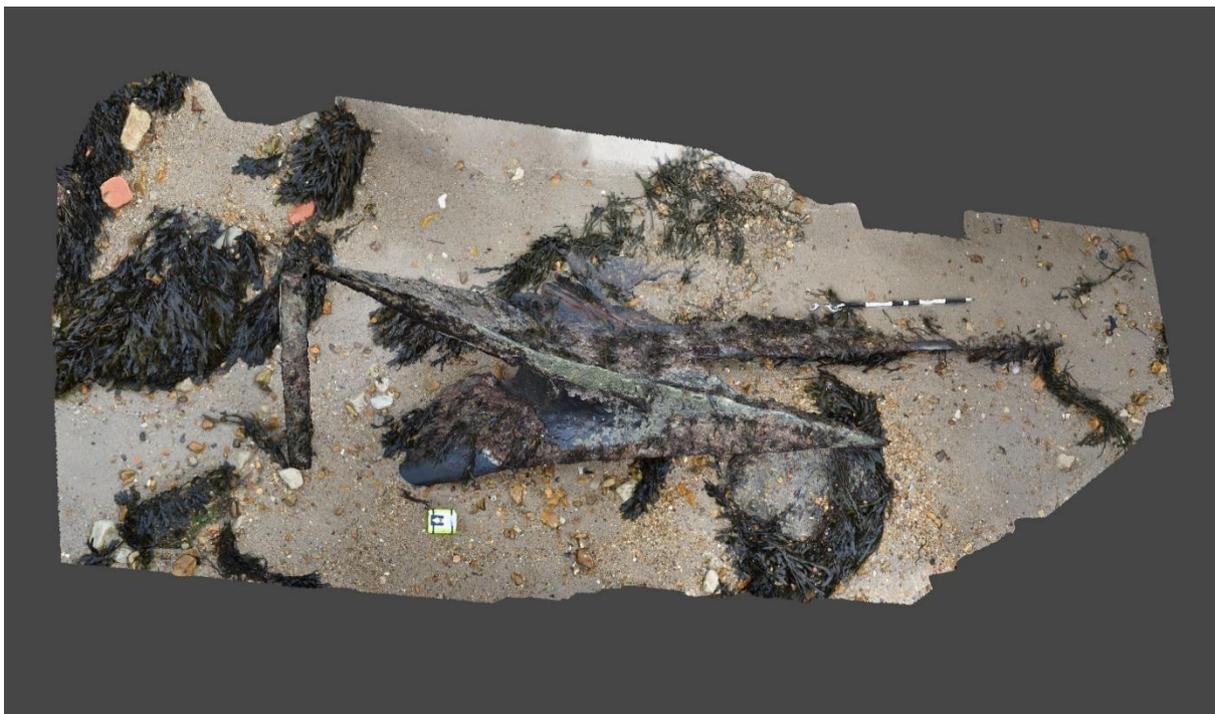
The anchor (K6) is positioned close to the edge of the beach and is some distance from the other anchors in the collection, being the furthest to the east. This Kite Anchor is in poor condition with the plough shaped hook and shank heavily corroded. There was a significant amount of marine vegetation on this anchor being positioned in shallow water which has

given rise to rapid growth of the seaweed. A photogrammetry model of the anchor has been produced, the anchor being positioned on its side and the arm is partially buried in the sand.

Figure 25. The arm of K6 is partly buried. In the background are the pontoons/frames.

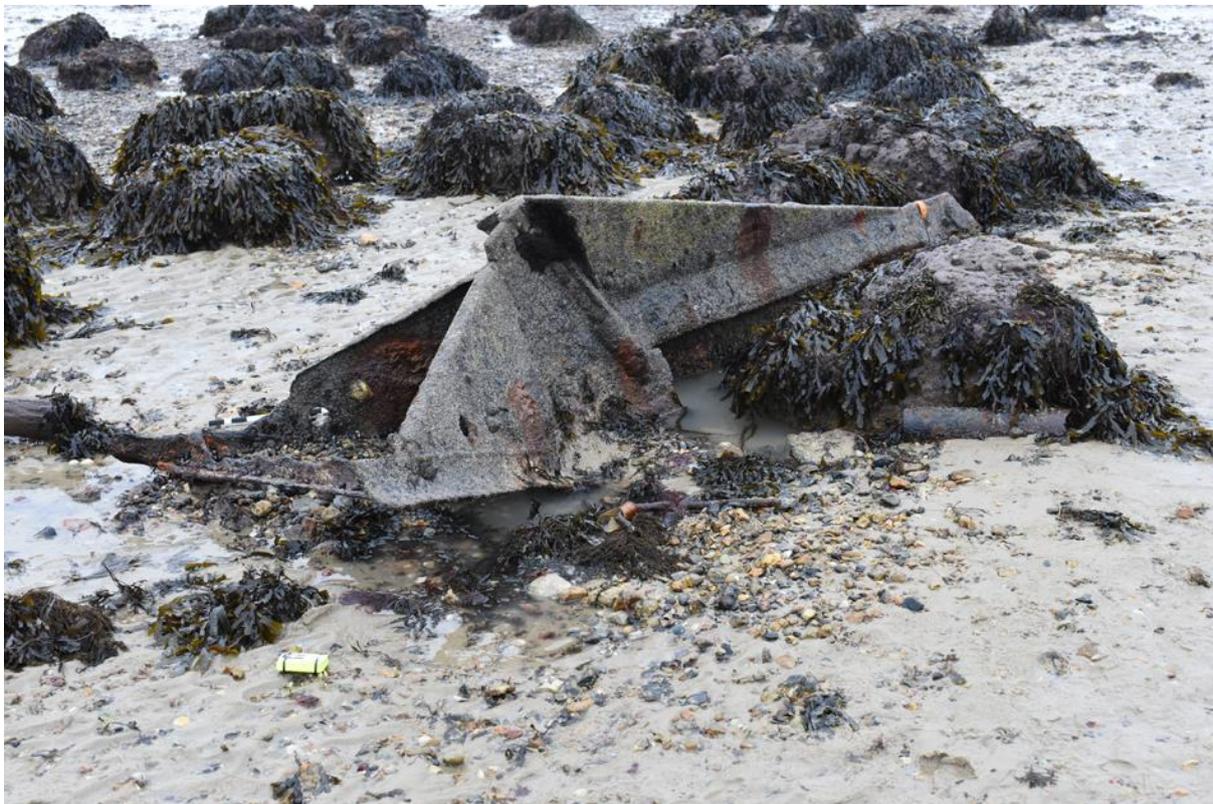
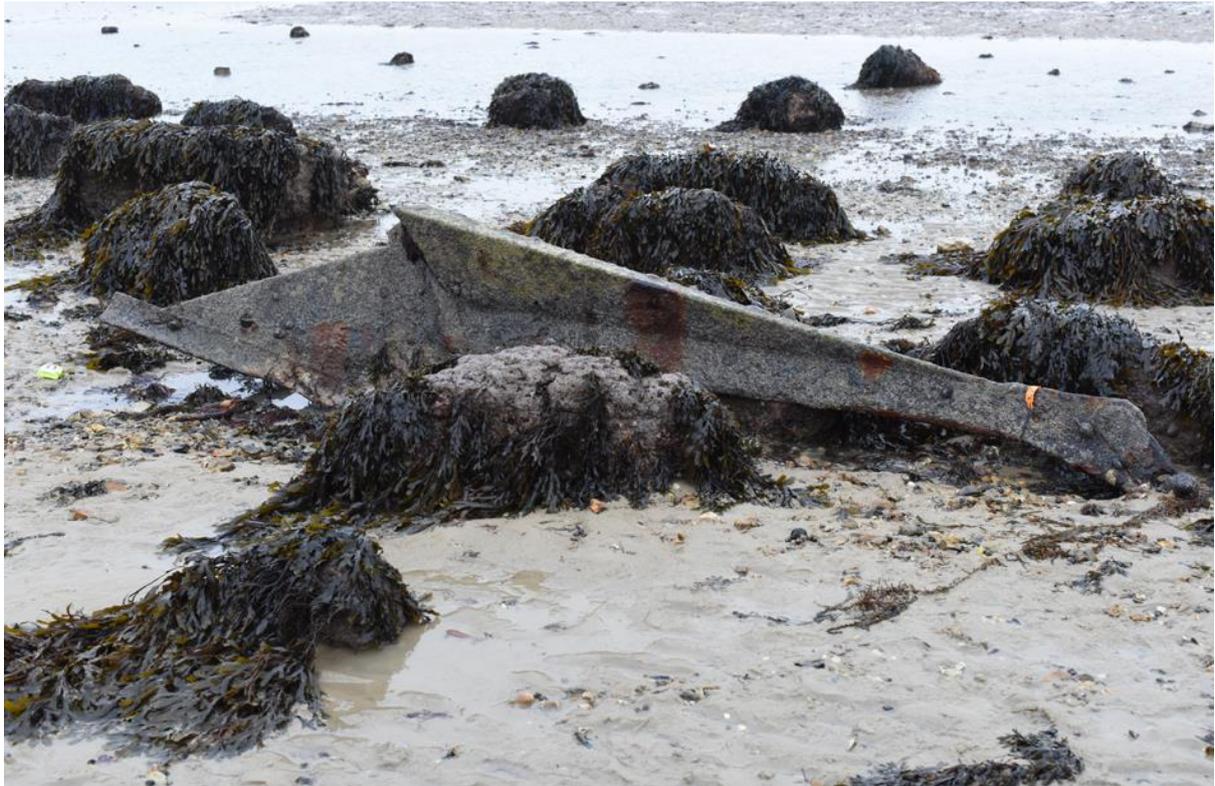
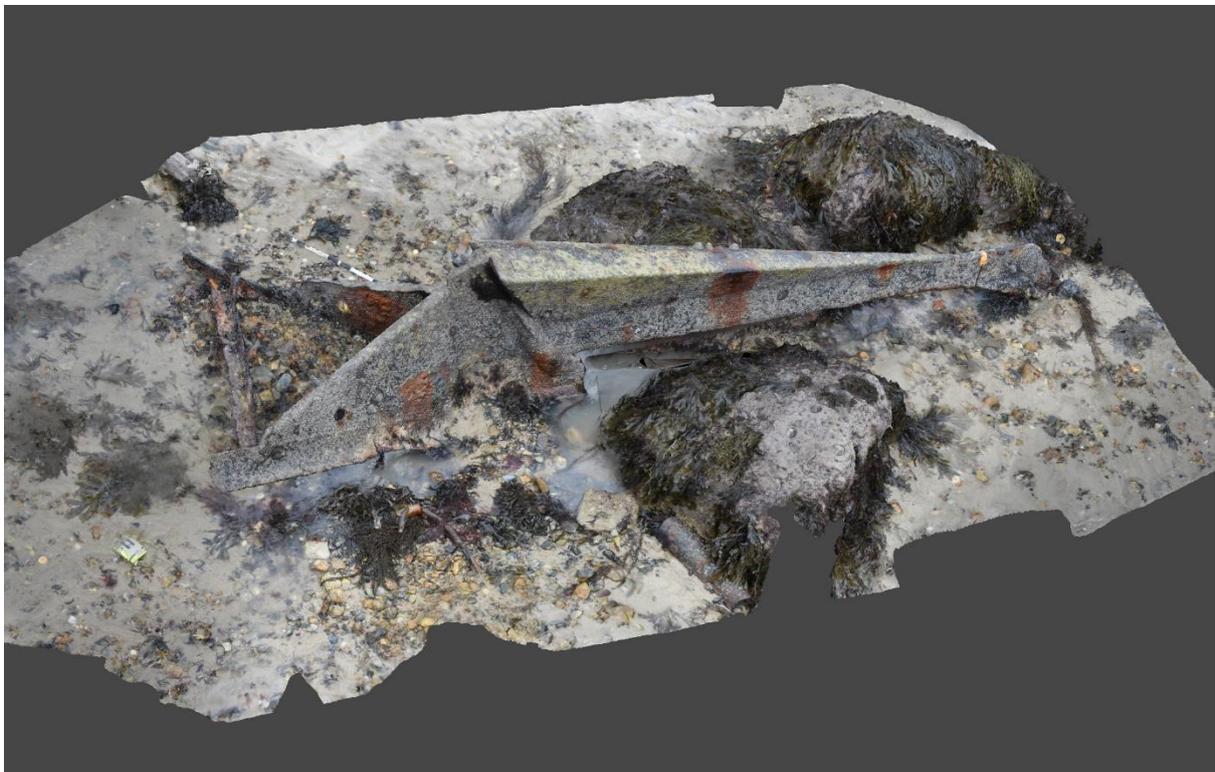
Kite Anchor K7 is probably in the best condition, being positioned mid-way in the intertidal zone with several rocks nearby. There is some corrosion of the hook area though this is not considered material. A shackle is present on the end of the arm but no cable is attached.

The arm appears to be in excellent condition in comparison to the other surveyed anchors. There is some concretion on it and some growth but it is in general very clean compared to the rest of the collection. A photogrammetry model has been made of K7.

Figure 28. Anchor K7 is in remarkable condition in comparison with the others surveyed.

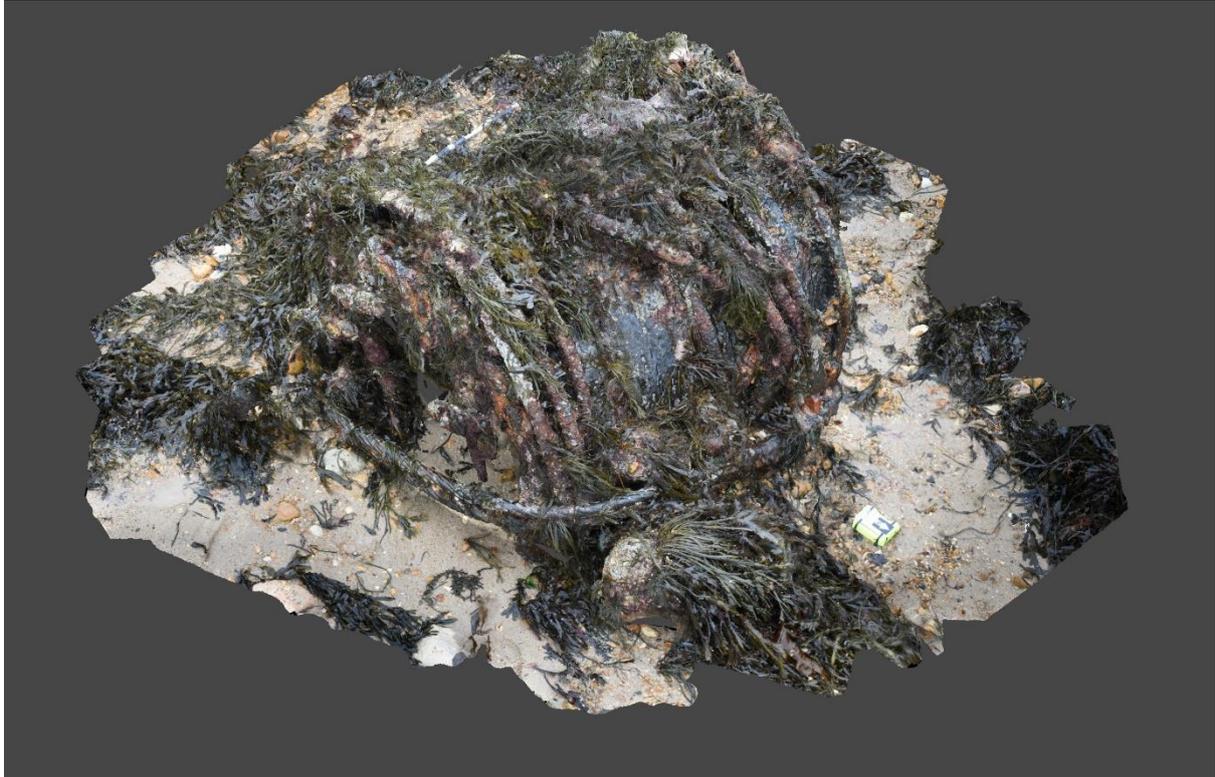
Figure 30. Reel 1 photogrammetry model.

Positioned very close to K6 is cable reel R1. The reel is heavily corroded and covered in seaweed though the cable is still wound. A photogrammetry model was made of the remains.

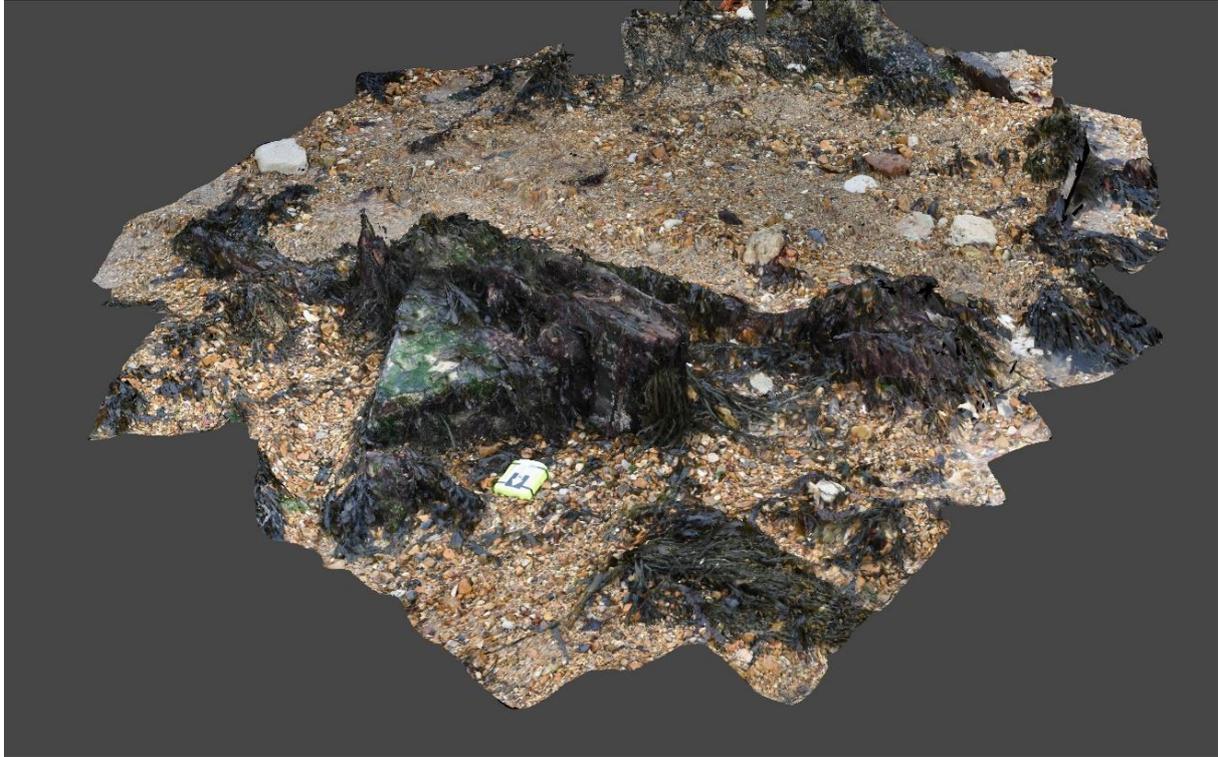
The remains of the mooring shuttle are adjacent to the reel R1. Only the heavy supporting construction parts now are visible. This item is part of the frame associated with the reel R1 and would have supported the reel on the shuttle and allowed it unwind the cable as required. It is located very close to the reel and the base is significantly corroded.

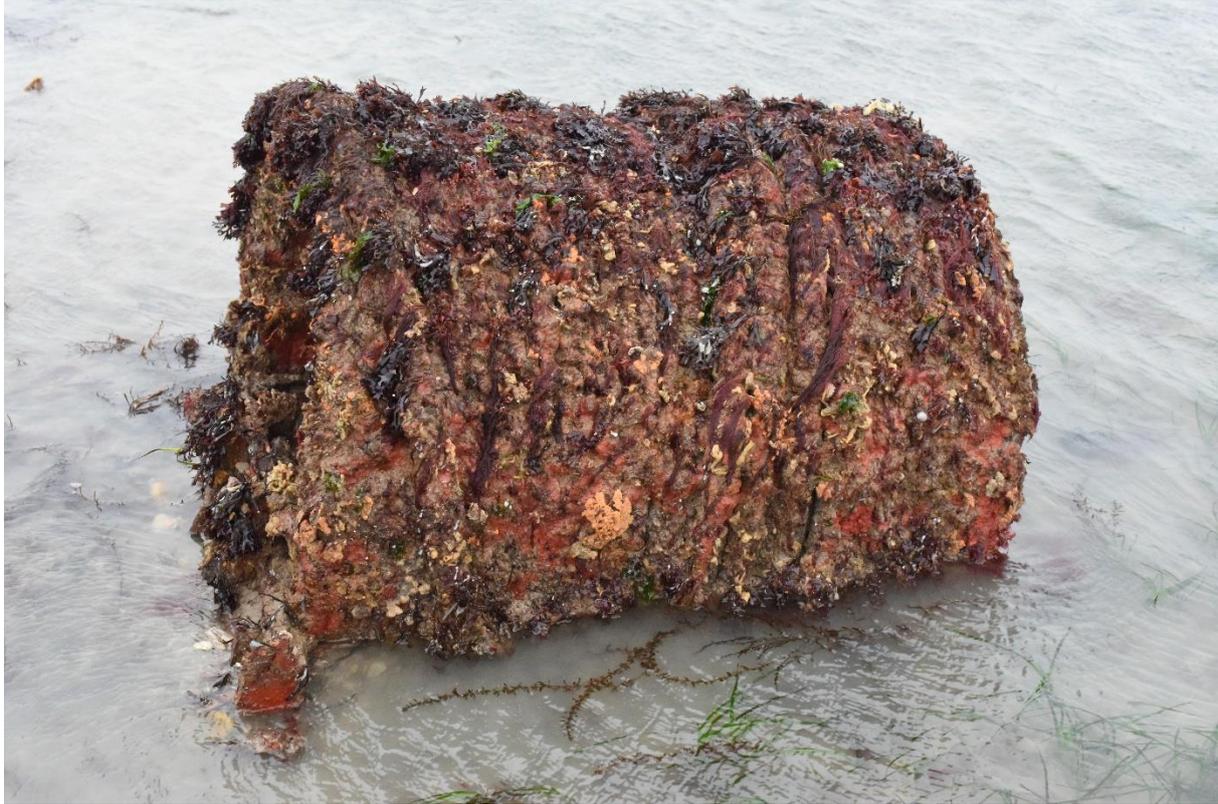
Reel R2 lies close to anchors K3 and K4 and also very close to the reel is part of its support frame that was used to allow the wire to unwind. The reel is complete with cable and is heavily concreted. This along with K3 and K4 would have been placed on a mooring shuttle and there are some buried remains of a shuttle near to R2 below the water.

Figure 32. Reel R2 at low water is on a sandy seabed with occasional sea grass.
