Securing Mulberry: Mulberry Harbour Kite Anchor Remains

**A historical and physical assessment of the archaeological remains
of Mulberry Harbour moorings on Peel Bank, off Woodside, Isle of
Wight**

May 2018

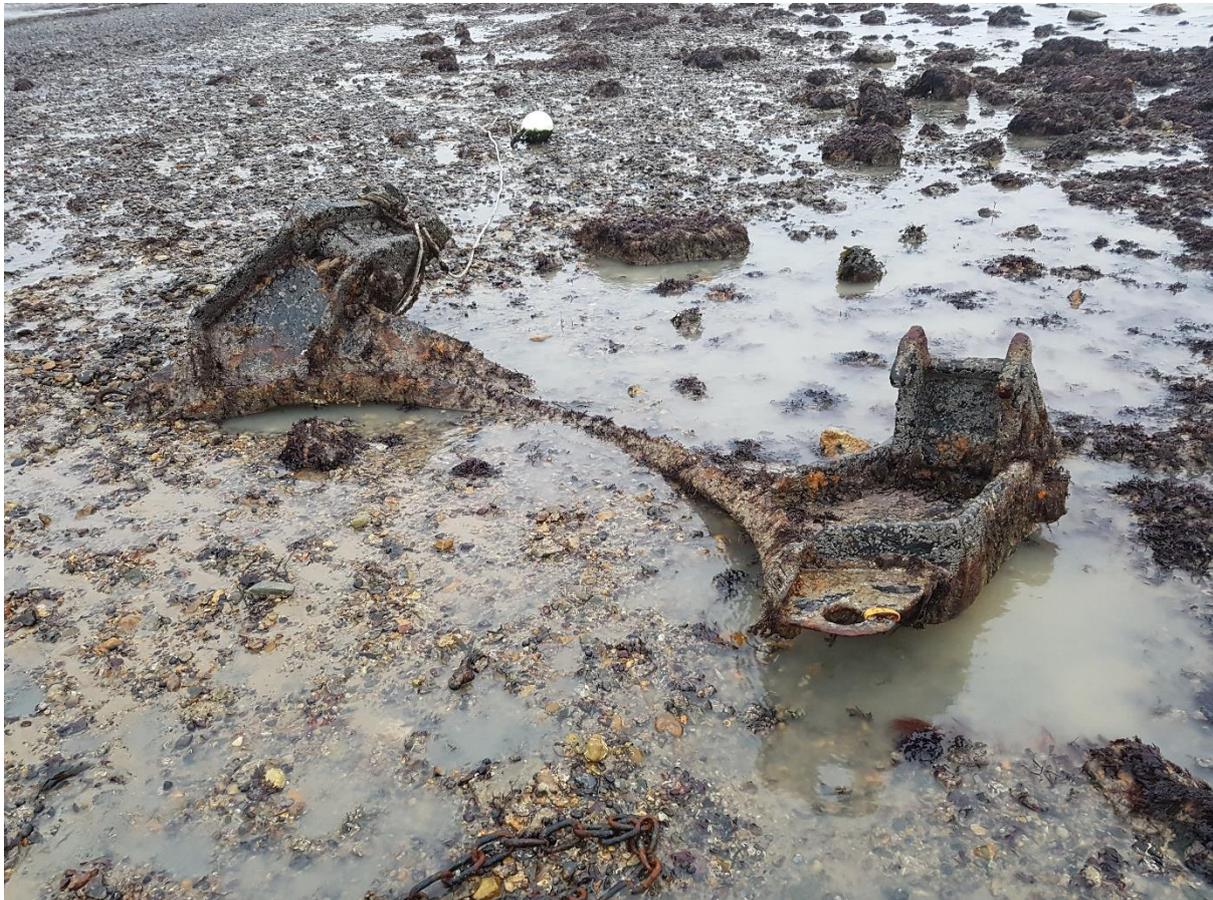
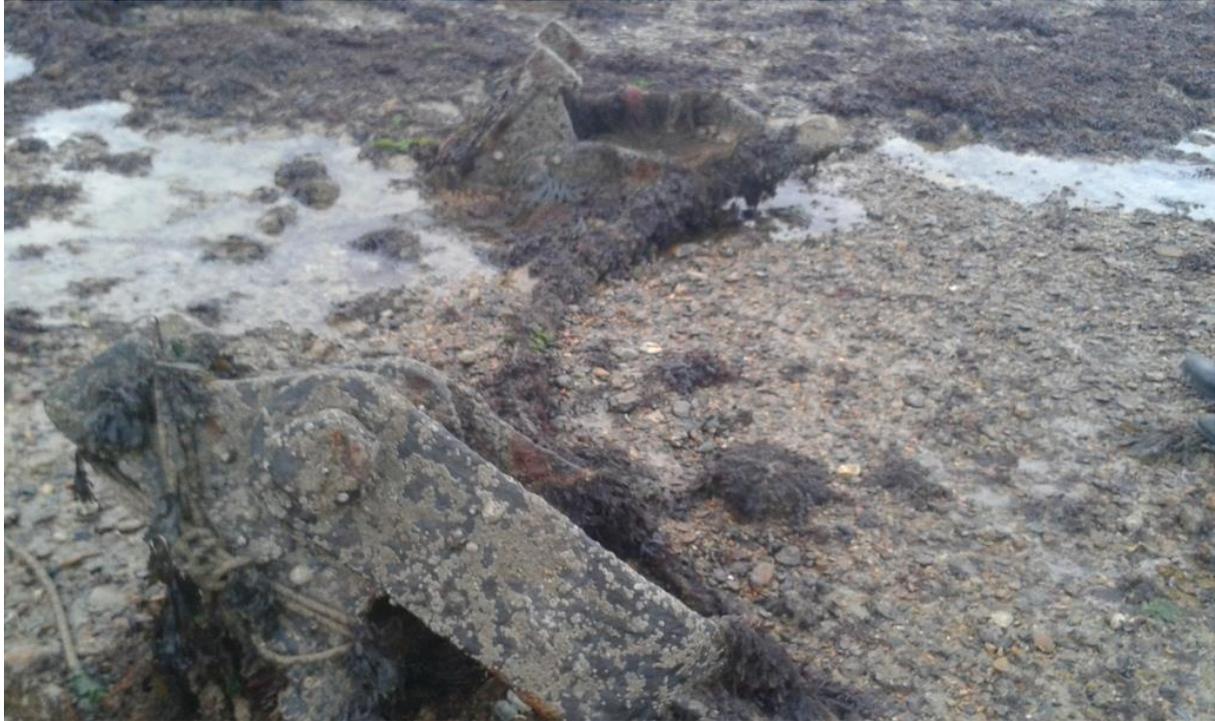
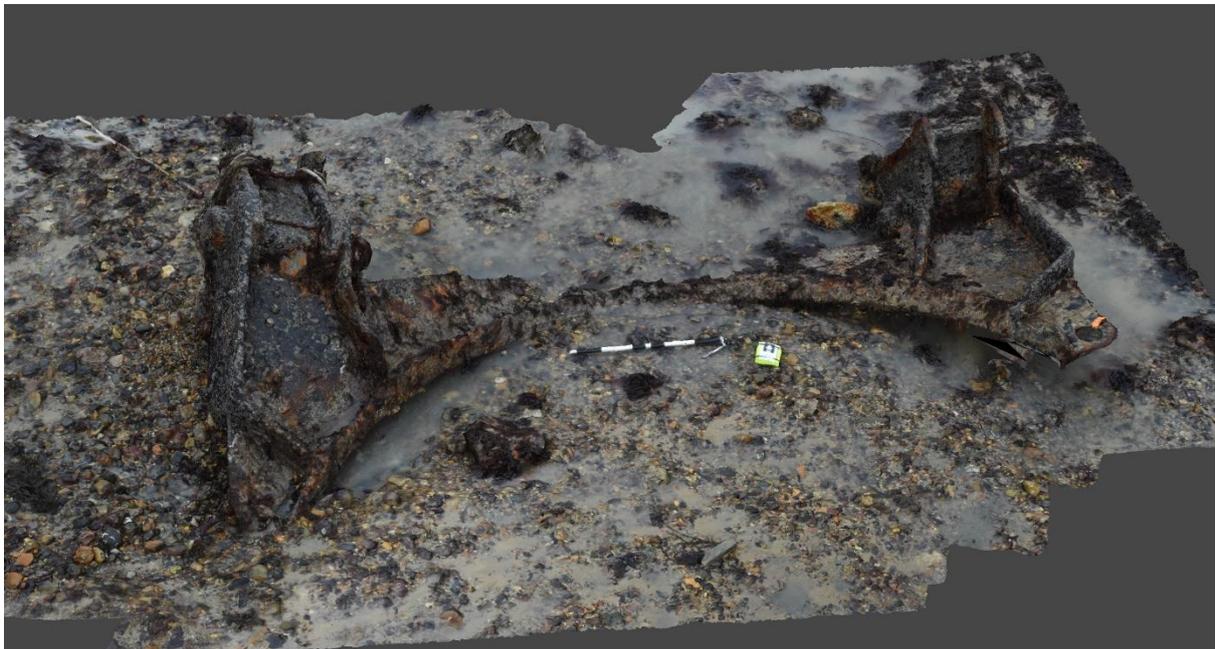
The remains of an erection tank saddle can be seen mid-way between K7 and K4 at the position given, this is a heavy construction item in reasonable condition due to the heavy gauge material use in its build. A photogrammetry model has been made of it, there is some light concretion over the surface of the saddle and only light marine growth.

The metallurgic properties of the steel may have changed considerably over time and there may be no strength left within the steel. There is a risk that the Saddle may also be brittle/fragile despite its fairly robust appearance. In the event that any of these anchors are removed it is recommended that they are placed on a platform and carefully supported during removal.
