FREETOWN PORT EXPANSION PROJECT, SIERRA LEONE

Abstract: Across the world in recent years, many complications have impacted on port development resulting from several world events that have been beyond the control of developers. The port of Freetown in Sierra Leone is expanding to accommodate more and larger vessels, especially for the handling of bulk cargoes. This paper focuses on the creation of the new ship berth at the Nectar Sierra Leone Bulk Terminal (NSBT), to demonstrate how substantial modern port construction projects can be achieved in West Africa, in the face of multiple complications, utilising creative and sustainable solutions. The project was to plan, design and construct the new ship berth adjacent to the existing berths whilst providing good navigational access. With limited spare land available inside the terminal, any newly reclaimed land would also help with port storage and operations. This paper provides explanations and technical details to expand on how the port design and dredging campaign was adapted to the specific requirements of the project, focusing on port planning, structural, geotechnical, and contractual issues.

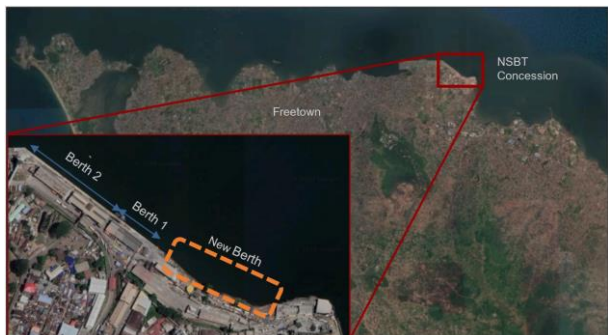
Figure 1 Location plan (Google Maps and NSBT drone photo). Map of Freetown, Sierra Leone with enlarged image of NSBT terminal and outline of the New Berth.

Freetown, Sierra Leone, is home to the West African Coast's largest natural harbour. The historic port is a bustling hub of import/export and a significant source of the country's economic prosperity. It is divided into two concessions by the Government of Sierra Leone, one of which is owned by UK's Nectar Group, operating the NSBT bulk and break-bulk terminal since 2015 following a successful international tender, see Figure 1 below.

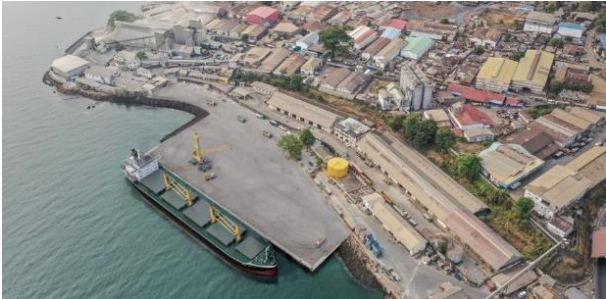
Figure 2 Artist's impression (EGCM). Design stage aerial view showing the eastern end of NSBT with visualisation of the new berth and cargo vessel alongside.

The only available place for construction of the new berth was at the eastern end of the existing berths. Here, the shape of the terminal and its coastline prevented continuation of the same berthing line and called for the new berth to be set at an angle, the degree of which was defined following consideration of water depths, ground conditions and anticipated current flows, see Figure 2. With previously constructed berths formed of various

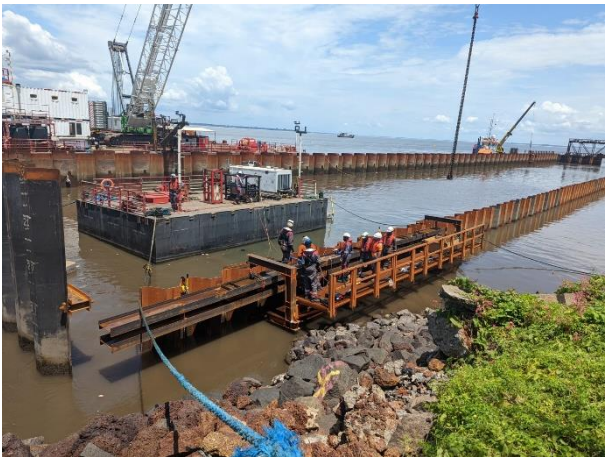
Figure 3 Piling underway (Site photo, Beckett Rankine). View from the existing terminal showing the new combi-wall berthing line and sheet piled rear anchor wall making up the cofferdam.

As early-stage site investigations were hindered by the COVID-19 pandemic and a limited budget and timeframe, the designers opted for a flexible approach. Using a range of ground models based on contemporary and historic information available for the site, the structure was therefore designed as a reasonably conventional, standard steel combi-wall. This was made up with large tubular piles and interconnected sheet piles in the form of a cofferdam with a continuous sheet piled anchor wall, see Figure 3.

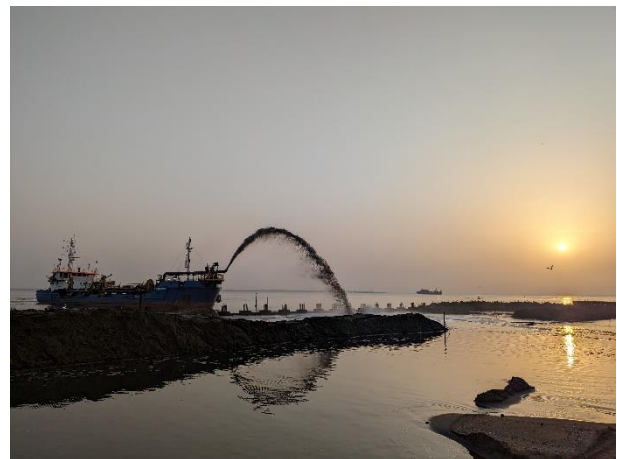
Figure 4 Reclamation campaign (Site photo, Beckett Rankine). Viewed from the shore in March 2023, the dredger rainbows sand into the cofferdam with fill already piled at the anchor wall.

Learning from previous projects in the area and available information of the geology around the harbour, good quality hydraulic fill material was sourced from a nearby area of seabed. This avoided the need to source material from onshore quarries, which would have provided good fill but at a much higher cost and greater disruption to the local roads due to increased vehicle movements. A reasonably small dredger (with a hopper capacity of approximately 1,000m³) was used because it allowed careful placing of fill in the structure at a controlled rate, using both rainbowing and piped delivery techniques, see Figure 4.

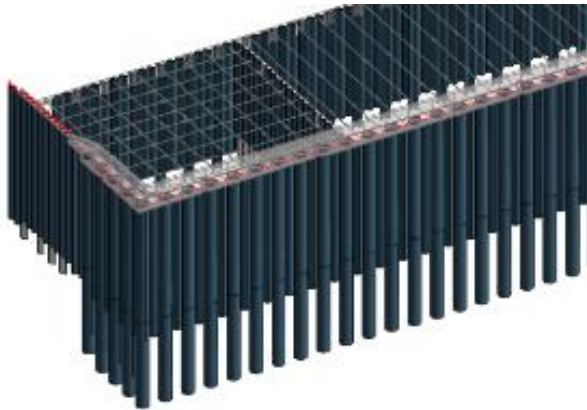
Figure 5 3D Revit model of the cofferdam structure (Beckett Rankine). Seaside view of the eastern end, showing combi tubular piles with intermediate sheet piles, tie rods and anchor wall.

All designs completed by Beckett Rankine had been modelled using Autodesk Revit Software, a BIM package for accurate and well-defined construction drawings, allowing precise and quick material take-offs and clash detection, see Figure 5.

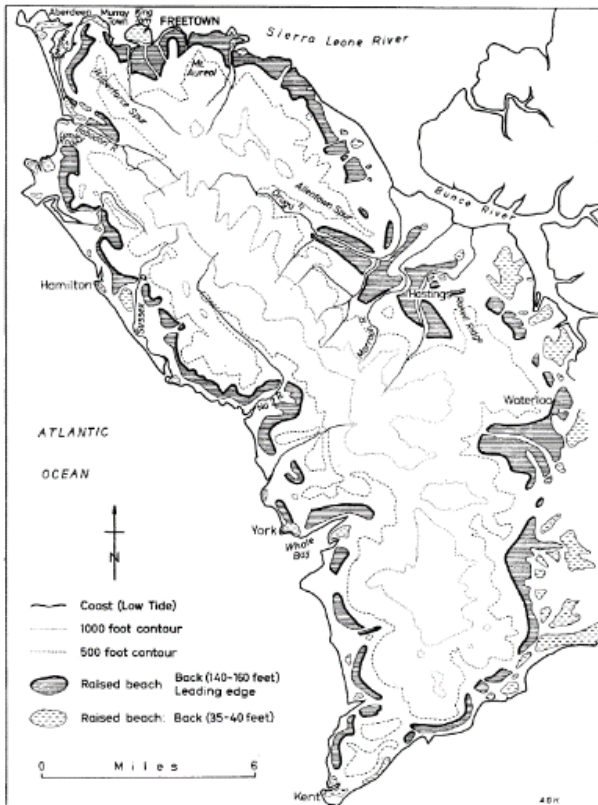
Figure 6 Map of Freetown Peninsula [4]. Raised beaches are shown along the coast including within the estuary, around the port and site for the new berth.

The coastal areas of the peninsula are defined by a series of raised beaches (see Figure 7) that are formed of unconsolidated clayey sand and silts that have previously been classified as part of the Bullom series [3]. The Bullom Group is the youngest stratigraphic group in Sierra Leone and comprises poorly consolidated Cenozoic sediments [2]. There have been very few detailed studies of the Bullom Group undertaken, however it is described as a poorly consolidation coarse quartzofelspathic sand. Moreover, the coastal deposits around the Freetown Peninsula are not contemporaneous with the deeper Bullom series and therefore have been cautiously classified as Bullom Group deposits for the Freetown development. The site-specific deposits are distinctly red in colour and weather / solidify into a laterite rock, which was observed as a common earthwork construction material across the Freetown area.

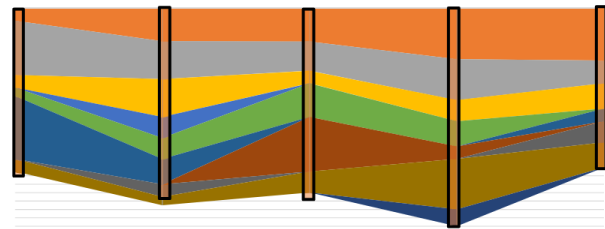
Figure 7 Offshore CPT campaign (AGTS). Stratigraphy profile below seabed along the new berth showing the large variations in elevation and thickness of various sand and clay layers.

When the piling commenced in June 2022, it became quickly evident that ground conditions were more complex than previously assumed. The piles were penetrating to a depth under self-weight or with less vibrations or driving force than was initially anticipated. Based on this, a series of offshore CPTs were procured using a ground investigation contractor from the neighbouring country, Guinea. Despite the complex properties of the clay presenting challenges for the CPT campaign, the successful CPTs were able to validate the highly variable nature of the ground across the berth, with the layers of clay and sand less defined than previously understood from the onshore boreholes and geophysics, see Figure 8 (showing very soft and soft clays in grey/yellow with variable density sands from very loose to moderately dense indicated by the blue, green and dark orange tones, ultimately underlain by a dense sand in dark yellow and stiff clay at depth). The CPTs also indicated that the softer material extended to greater depths than originally indicated.

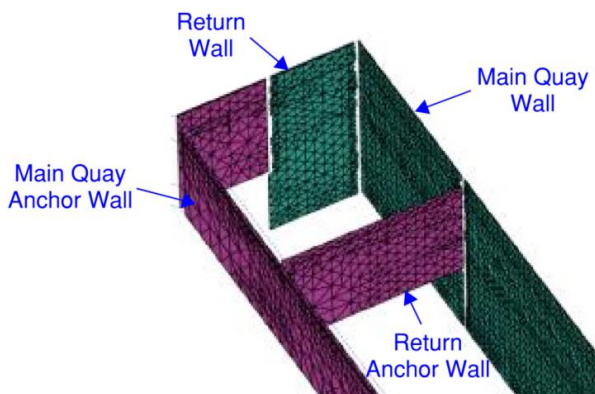
Figure 8 Plaxis 3D model (by subconsultants A-squared Studio Engineers). Geometry of the model at western end box showing key components with shore to the left and sea to the right. All soils and tie rods hidden for clarity.

Further to alterations to the project design, a monitoring system was put in place alongside a Monitoring Action Plan. This was developed based on the detailed 2D and 3D soil-structural interaction analyses carried out in Plaxis, see Figure 9. The reclamation sequence was assessed in Plaxis and broken down into several key sub-stages for which predicted displacements were determined. These were used to develop a traffic-light system of allowable deflections for the reclamation works.

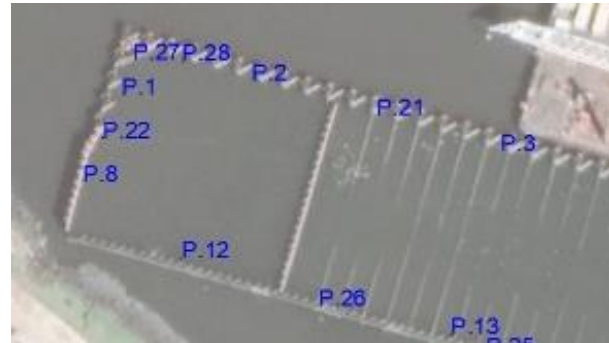
Figure 9 Plan view of berth construction (Google Earth). Showing monitoring target locations at western end box.

The monitoring system comprised a series of targets installed on all the pile walls and tiltmeters installed on the main quay wall. The prisms were 'pinged' by an automatic total station that provided updated movement readings on an hourly basis. The data was automatically uploaded to an online portal, allowing access for the engineers in country and the design team in the UK. Mobilisation and installation of inclinometers was considered but was decided against due to timescales of procuring the equipment and difficulty of installation.

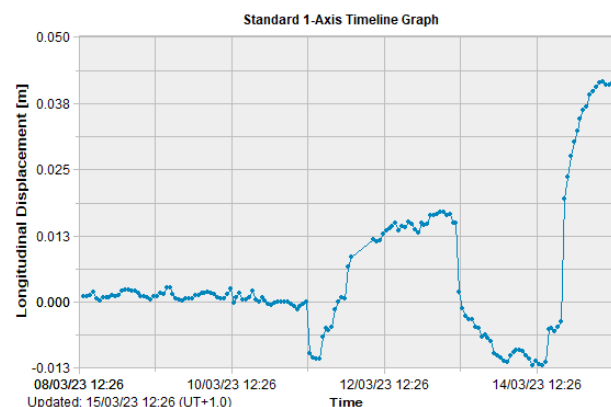
Figure 10 Monitoring data (Sitinfra Sarlu). Example wall deflection data on anchor wall. Tidal variations visible along with filling and tie rod engagement indicated by reverse movements.

The reclamation works were carried out under a controlled sequence of stages, using an observational method to track displacements against predictions, whilst feeding real-life results back into the Plaxis models. Beckett Rankine provided an on-site geotechnical engineering representative to work collaboratively with the dredging contractor and main Contractor to adapt the sequence against the monitoring results and design calculations. The dredger was a Trailing Suction Hopper Dredger (TSHD) with relatively small hopper capacity up to a maximum of 1,000m³, although most loads were between 700-800m³. Each load was delivered within an approximate 3 to 4 hour window, allowing live multiple monitoring data readings to be reviewed to understand the

behaviour of the box ahead of each load, see Figure 10. The monitoring data indicated that the filling had an almost immediate effect on the cofferdam walls, giving an indication of the sand quantities within the shallow soft clay layer increasing the permeability of the ground.

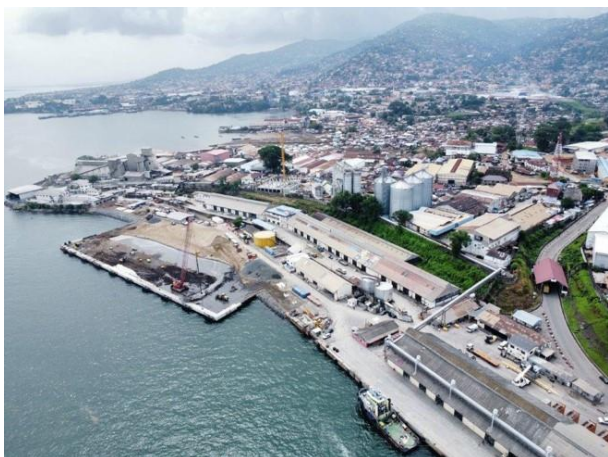
Figure 12 Drone photo (EGCM). New berth approaching completion in December 2023, showing crawler crane installing stone columns. Fenders and bollards in place.

The ground improvement works originally entailed vibro compaction of the hydraulic fill to ensure it was uniformly compacted and to reduce further settlements once the berth is operational. However, considering the ground conditions, the ground improvement design was adapted to include stone columns within the underlying soft clay. These were constructed using the same vibration compactor

poker, with the stone only placed over the clay column height. Further CPTs were undertaken after the reclamation and ahead of the ground improvement works to allow an accurate profiling of the hydraulic fill and clay layers, so that the work could be optimised for the relevant vibro compaction and stone column vertical extents and transitions. The stone columns were placed on a regular grid across the cofferdam box to enable faster consolidation of the soft clays under the weight of the hydraulic fill, improve the clay properties through consolidation and enable better load distribution to reinforce the clays. The ground improvement will reduce long-term settlements of the berth throughout operation, future maintenance of the berth pavement surface is anticipated to be within standard requirements for a typical bulk terminal berth.
