MAKING THE INACCESSIBLE ACCESSIBLE

D J Tresidder, Beckett Rankine Limited, UK **W Davies**, Wyn Davies 5201 Consultancy Limited, UK

SUMMARY

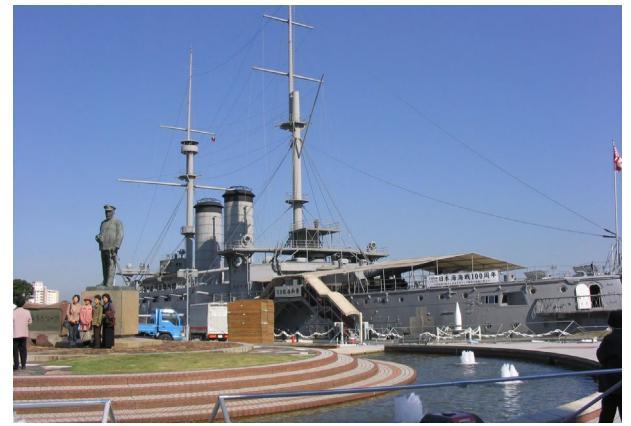
As noted in the Introduction, keeping a vessel on land can often lead to problems of structural distortion and damage. It is worth noting that some US Navy submarines have been embedded in gravel in an attempt to mitigate this problem. Good drainage is required to ensure facilitation of the driest and least corrosive or rot inducing environment possible. However, a gravel environment is less effective at hull preservation than a low humidity environment such as fresh air, or a high alkaline environment such as a solid concrete surround in the case of the Japanese battleship *Mikasa*.

Figure 1: Japanese Battleship Mikasa

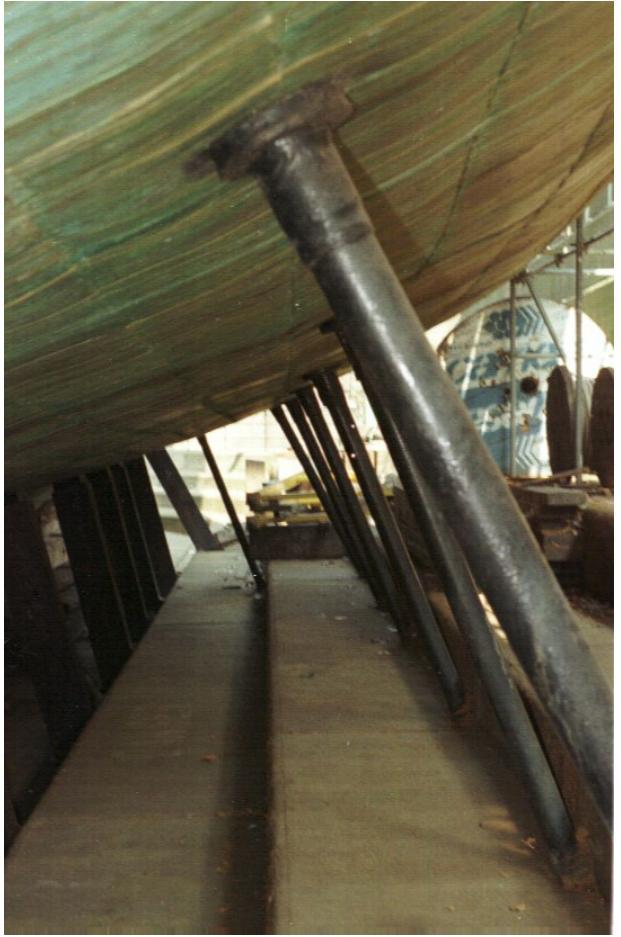
This is not a solution that can be applied universally and, in many cases, may not be appropriate. The most important feature of the *Cutty Sark* for example, is her hull form. As the only surviving extreme clipper, her elegant lines had to be visible to the visitor. Severe local hull deformations caused by the original simple props have been addressed in her current support solution which includes support from a significant internal structure tied to the dockside. Current work on HMS *Victory* has led to a new design of a structure to provide better all-round support than the original for similar reasons.

Figure 2: *Cutty Sark's* original supports, note localised deformation of hull

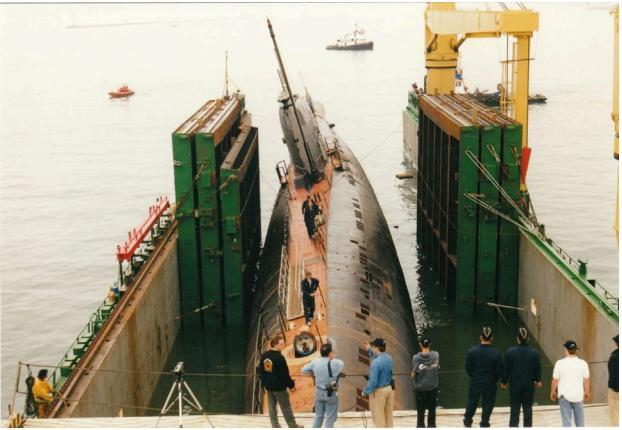
An underwater inspection was carried out, although visibility was not good. This revealed that the recent crack was just the latest activity arising from a large deformation. It was subsequently discovered that this dent had been caused during unloading on delivery some 17 years previously. The event had gone unnoticed but it was recorded on at least one photograph taken at the time.

Figure 3: Unloading the submarine at its destination (photo courtesy of Steve Wilson's internet page: *http://blastitcleanitpaintit.com.au/photo-gallery/*)

Once finally afloat the dent was totally underwater and thus would have only been visible to a diver. Clearly no diver had inspected the craft (or at least had not noticed the damage) and a crack had continued to develop over the years until it was nearly two meters vertically and the bang was the result of the crack spreading horizontally for about a further meter, caused by differential water pressure following the attempt to pump the tank out.

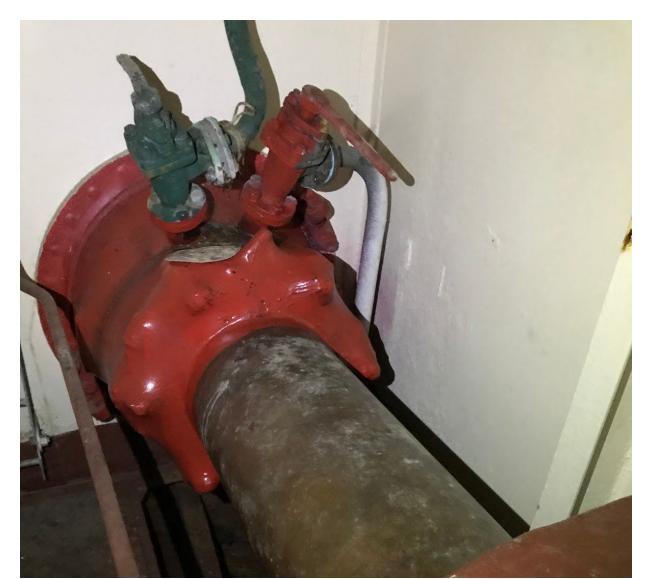
Initial surveys were also able to verify the condition of the prop shaft glands and that the seals put in place remained in good condition.

Figure 5: Sealed prop gland of HMS Belfast

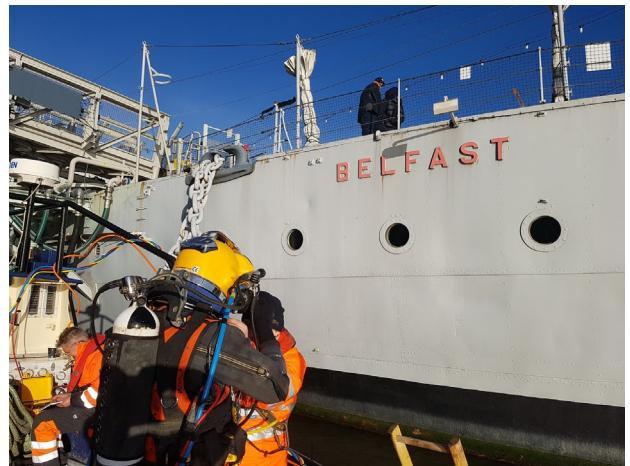
In the case of HMS *Belfast*, high quality modern cameras were used which have a rear screen so that the diver could judge when a good image was being recorded and know when to move on. This was found to be the most effective method of minimising the survey time. A box was sealed to the hull using a soft neoprene seal and magnets around the edge to clamp it in place. Fresh water was pumped from the survey vessel and injected into the box from two sides with the excess water flushing out of holes on the remaining two sides. The camera was mounted at the rear of the box with the box being deep enough to achieve focus and optimum lens angle for the camera.

Figure 7: Diver preparing for the hull survey of HMS *Belfast*

The box would clear after two or three minutes with noticeable improvement in image quality after that time. Artificial light was added to illuminate the hull through the box and both still and video clips were taken. Marine growth was cleared by hand prior to attachment of the box.

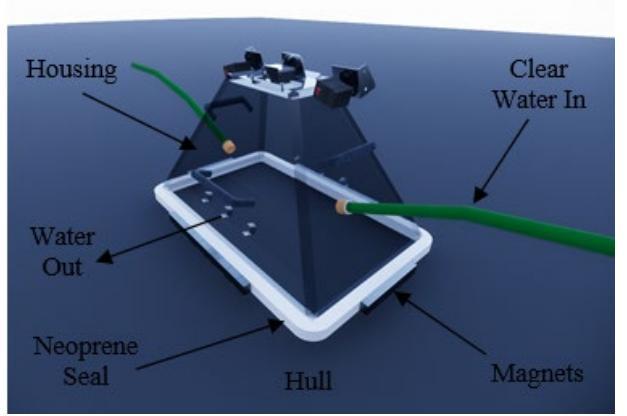
The ability to adjust the magnets to form a close seal between the box and the hull, while the seal retained sufficient compressibility to accommodate the radii of the hull, was found to be critical to the success of the clarity of the water and image quality.

Figure 8: Diagram of a clear water box

The principle of a clear water system is to replace the turbid water between the object being viewed and the point of view with clear water. The view may be achieved by the diver through their face mask, a camera, a remote video camera or a live feed video camera back to the surface. Each has its own merits and drawbacks and the decision on which to use is influenced by the competence of the diver to take the images / video and the ability of the surface team to effectively communicate with the diver from the surface.

Using the clear water box, cross cut adhesion tests in accordance with the Steel Structures Paint Council Standard D3359, were possible noting the adhesion tape limitations. This destructive test damaged the corrosion protection. Locations were, therefore, carefully chosen that were likely to be representative of the typical paint adhesion but where the hull thickness was such that future corrosion would not be critical (the advantages of surveying an armoured vessel).

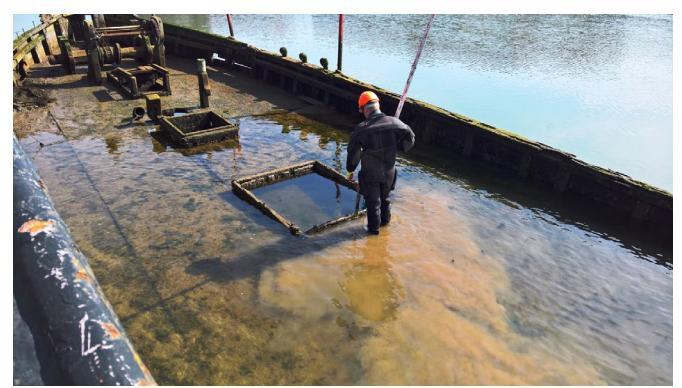
In the case of the wooden sailing trawler *Esther*, sunk in Alexandra Dock, Grimsby, it was clear that significant volumes of fine silt had accumulated inside the vessel. At low water her deck was exposed. The decision was made not to send divers inside the vessel in the first instance as the water was relatively clear. Instead, a pole mounted camera was used to record the overall condition and details in good visibility. Subsequently a diver was directed inside to dimension members and to undertake knife penetration testing. However, this was primarily tactile due to poor visibility as the silt rose in plumes as soon as the diver entered the vessel. Where necessary, the measuring tape was locked and read in clear water or back on the surface.

Figure 9: *Esther* – Using a pole mounted camera prior to a dive into the interior

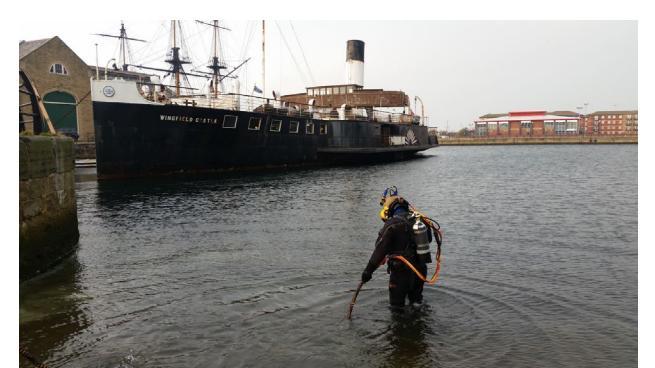
The paddle steamer *Wingfield Castle*, at her berth in Hartlepool Harbour, presented a challenge in terms of the extensive soft marine growth that extended over the majority of her hull. It was necessary to adopt a representative sample approach to the survey despite the relatively good underwater visibility, as clearing the marine growth would have turned a one day survey into something closer to 10 days. Patches of marine growth were cleared and the sample survey was, in effect, the same as one that would be undertaken in low visibility conditions. The marine growth however, became less prominent along the keel line away from direct sunlight. A more comprehensive survey was therefore possible at the location where the vessel was more likely to have suffered damage from having run aground, for example.

Figure 10: PS *Wingfield Castle* at her berth in Hartlepool Docks
